## PART I: DESCRIPTION AND SUMMARY OF FINDINGS

## The Original House, c. 1725-35

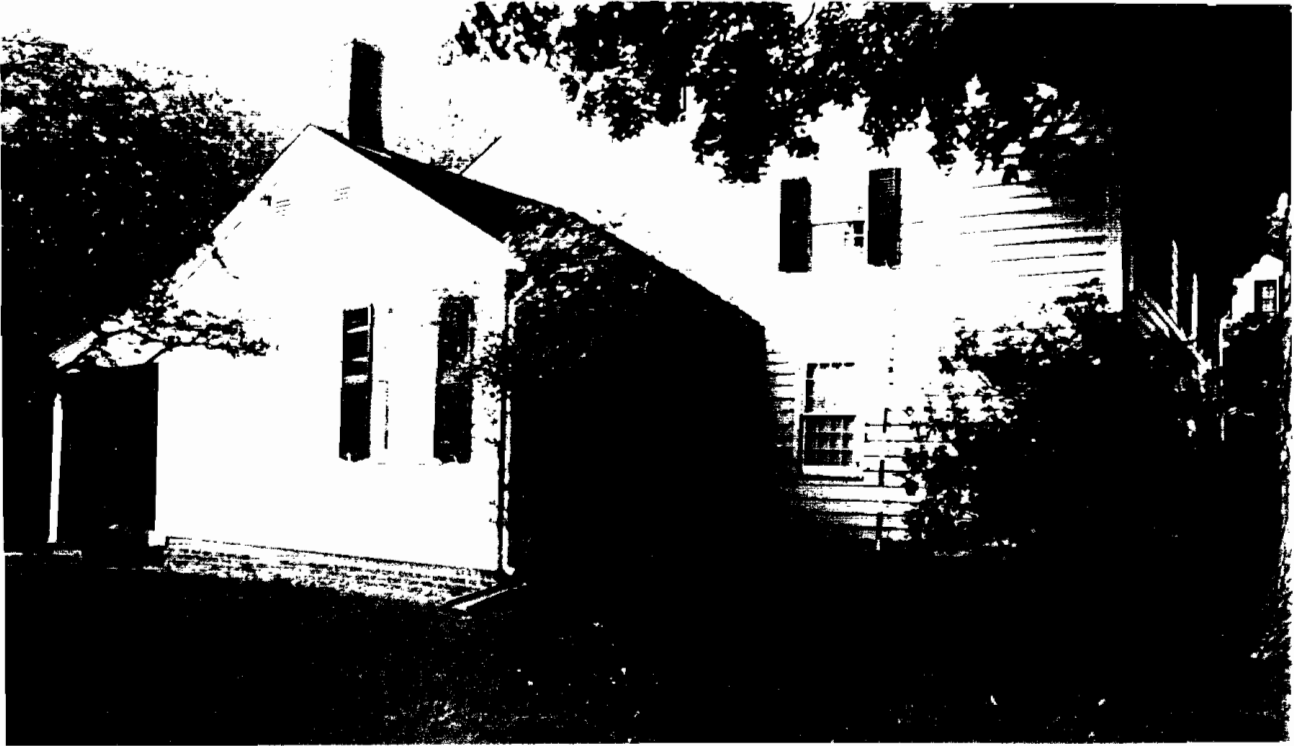
DES - 3 WEST

We are uncertain whether the west wing is contemporary with the eastern additions. It was clearly added after the main section was remodelled, as it covers a section of the weatherboarding on the house's west wall. The wing encloses a single room with Federal-style woodwork, perhaps a parlor or office.

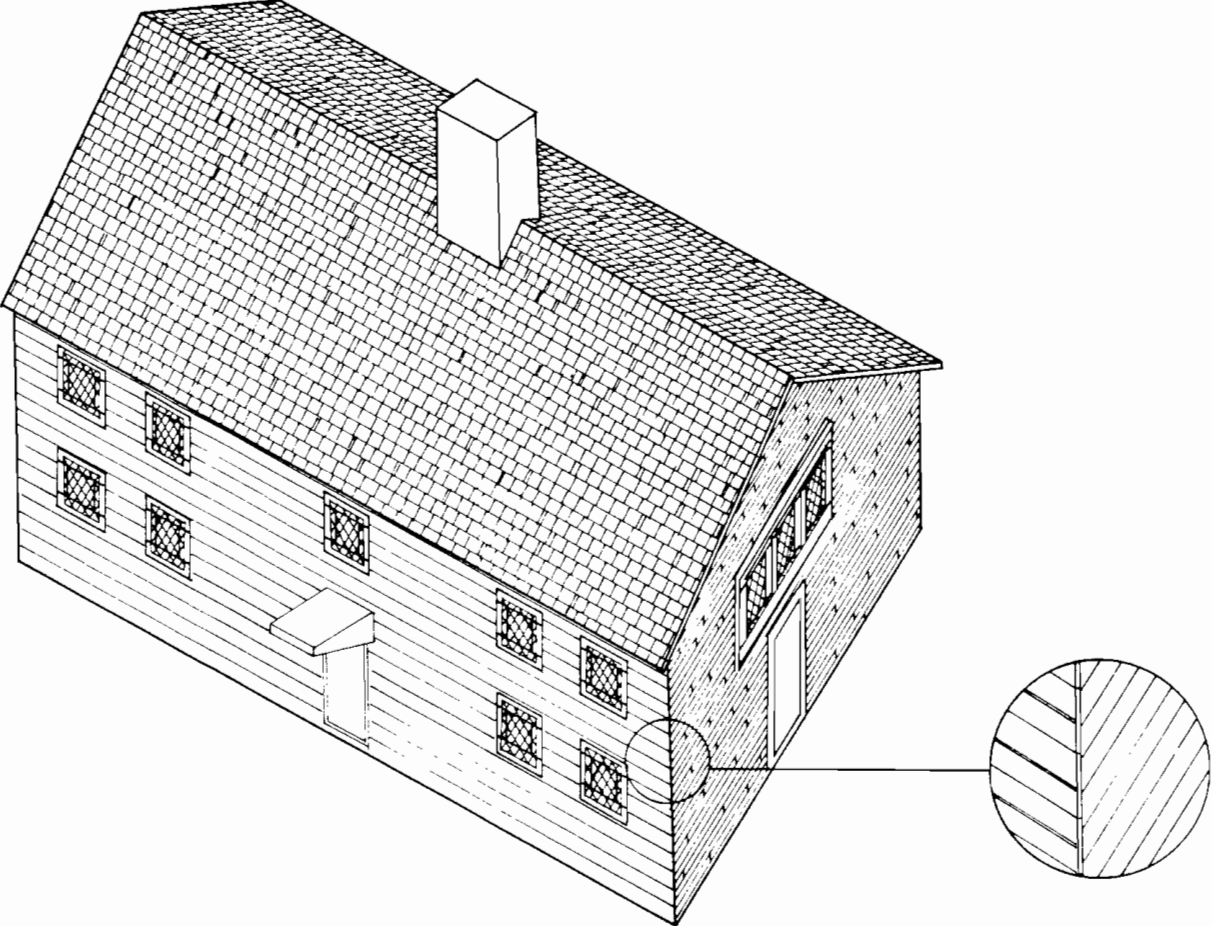
The exterior was sided with four slightly different materials: wide flush boards on the facade scored horizontally to resemble weatherboards, weatherboarding on the gable ends, and unscored flush boards on the rear. All of these survive under later coverings.

Some details in the illustration are partly conjectural. The size and locations of only six window openings have been verified (not all of which are on the sides illustrated), but these suggest a regular fenestration pattern. The evidence for leaded, diamond-paned casements, as opposed to the transitional, wooden, square-paned type - is entirely documentary. Local historian Sylvester Judd noted c. 1832 that "the house 50 years ago had diamond windows." Wooden casements or sash were new window types in the first quarter of the eighteenth century, and may have been relatively slow in reaching the Connecticut Valley.

We know very little about the appearance of the pentice or hood above the front door, only the tenons of which survive. Similar hoods found on other early Connecticut Valley houses seem to have been relatively plain and practical.

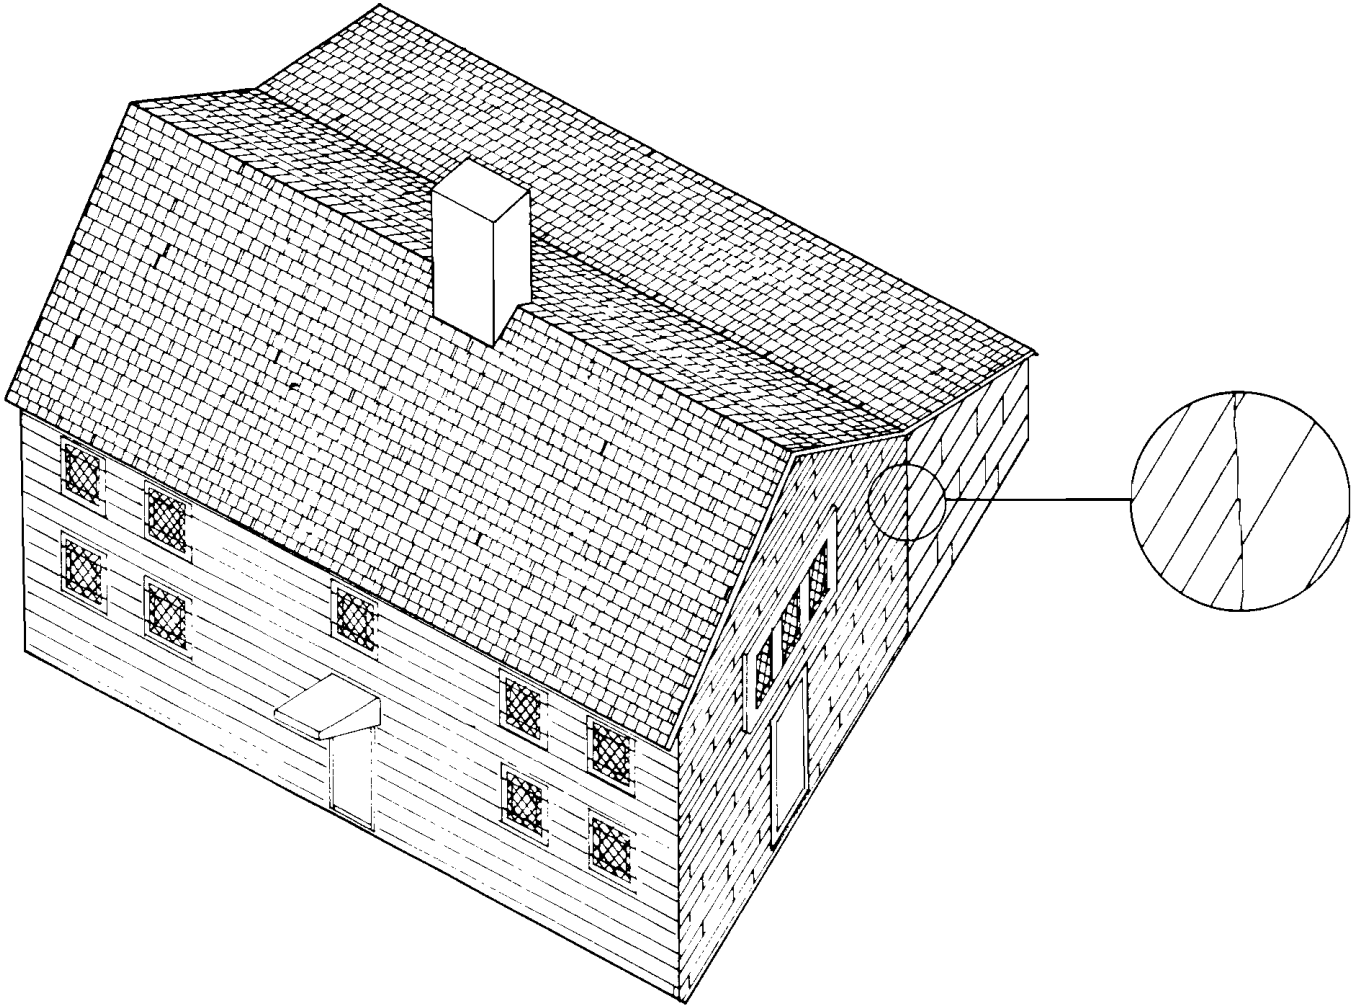
We can not precisely date the lean-to on the basis of physical evidence. The house was owned jointly by two Parsons heirs from the 1750s until 1785, and roughly east/west division of the house between two families might explain the need for two kitchens. It is just as possible, however, that Nathaniel's widow took in a tenant or boarders, a situation which might have required a second kitchen. The original kitchen continued to serve as such until c. 1800, when it was made into a parlor.

The lean-to was sided with wide rough boards, rather than clapboards, weatherboards, or planed-board siding.

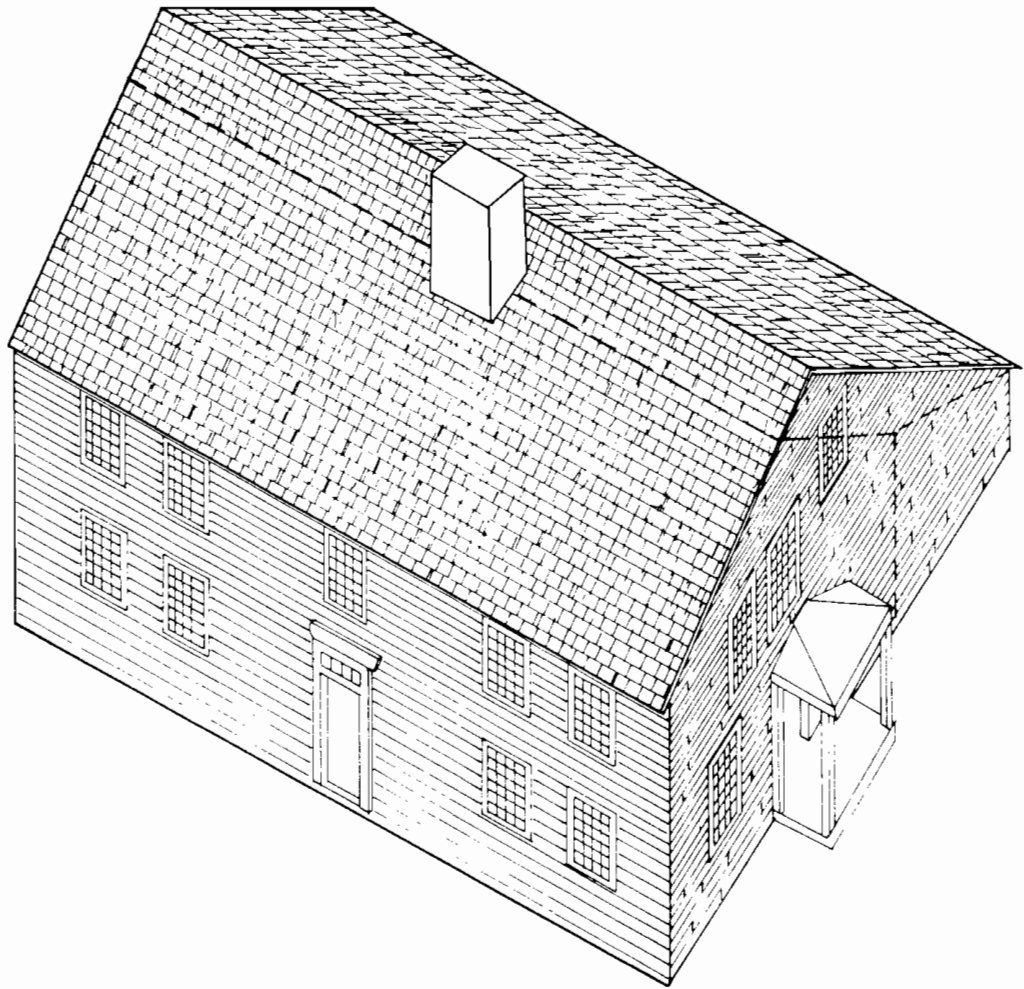
A second floor was added to the lean-to in the later eighteenth century, requiring that the old roof be replaced with one of almost twice its girth. This completed the transformation of the original house from "single-pile" (one room deep) to "double-pile" (two rooms deep) on both stories, and gave the main section its present form.

This project was part of a grander scheme which also included a major interior/exterior remodeling. The present weatherboards were nailed over the by-now deteriorated original siding, and the old casements were replaced with hung sash. The simple door surround with flat arch had a vaguely Federal-style feeling, but the spirit of the upgrading was far more practical than stylistic. The old house was too small and no longer weather-tight.

The dating of these major changes to 1795-1815 depends largely on nail evidence. The siding is attached with wrought nails, whereas all of the split-board lath and most - but not all - of the interior woodwork is fastened with an early form of cut nail. The first fifteen years of the nineteenth century are the primary transition period between these nail types.

The form of the new roof frame, particularly the pegged, hexagonal ridge pole, is also typical of the last quarter of the eighteenth or very early nineteenth centuries.

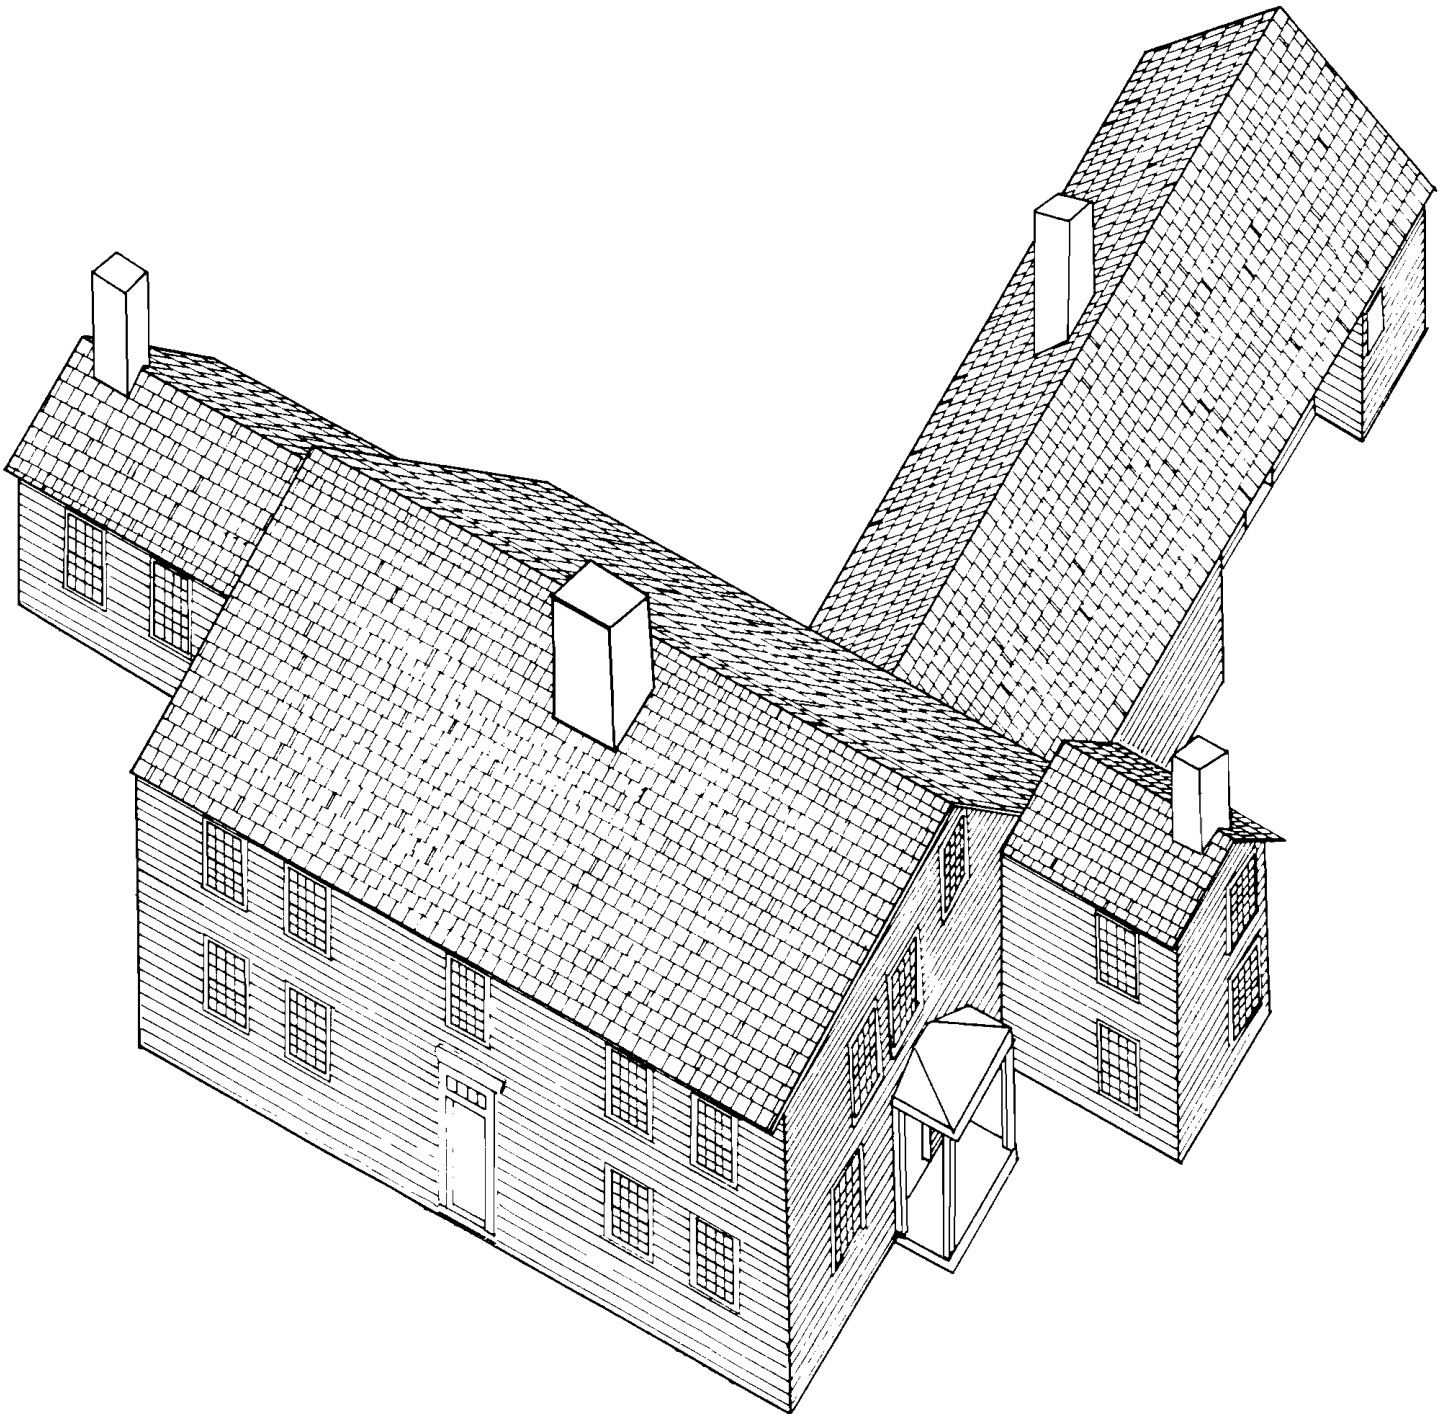
The ell and east wing appear to be contemporary, and to post-date the remodelling of the main section. The physical evidence does not allow the interval to be described with any certainty, but the work was completed by 1830.

We know that these additions occurred after the main section was remodelled because two doors connecting the main house and the east wing were added after the older rooms had been plastered (see rooms 102 and 202).

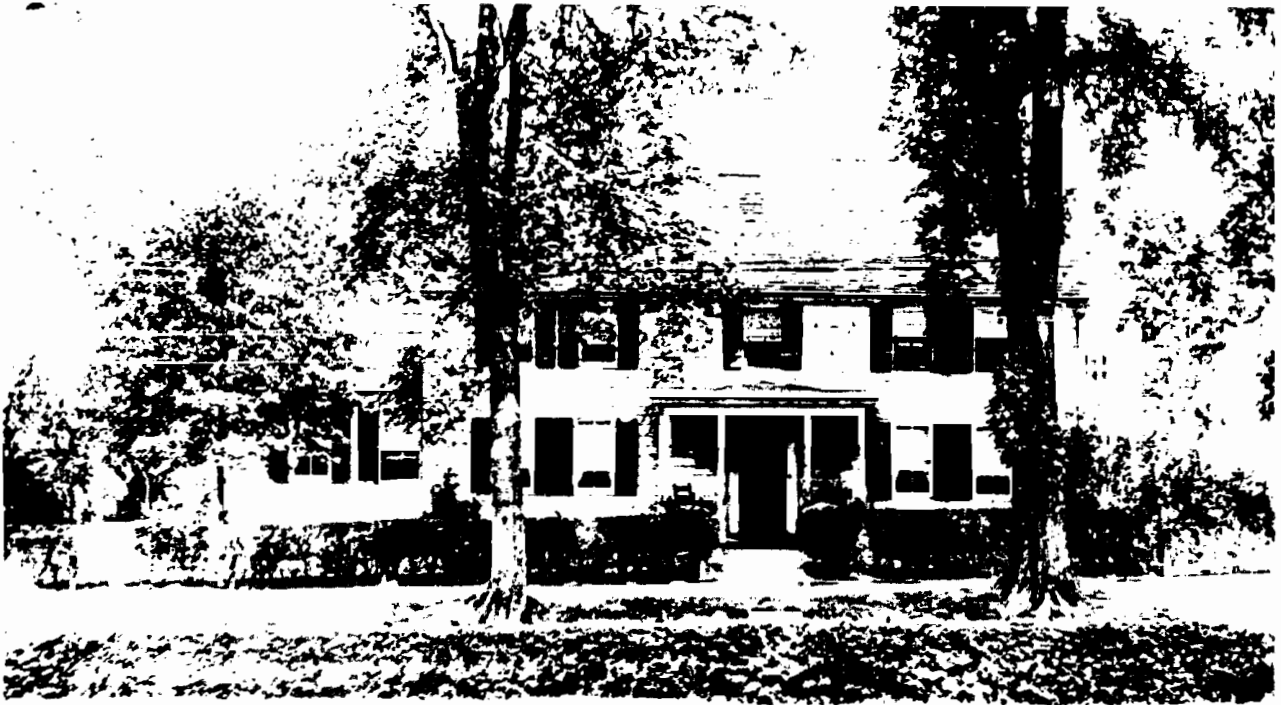
DES - 5

A front porch with turned balusters was added to the facade in the early 20th century. This had been replaced, by the 1940s, with a similar porch of squared columns. The later porch was removed by the 1970s.

The 2/2 windows in the photographs likely date to the early 20th century, and may be contemporary with the new porch. These began to be replaced with multi-paned windows in the later 1970s (bottom photo), a process completed by the later 1980s.
