## EXCAVATION EXT-W1 (WEST WALL)

### The Original Siding of the Gable Ends: Thin Weatherboarding

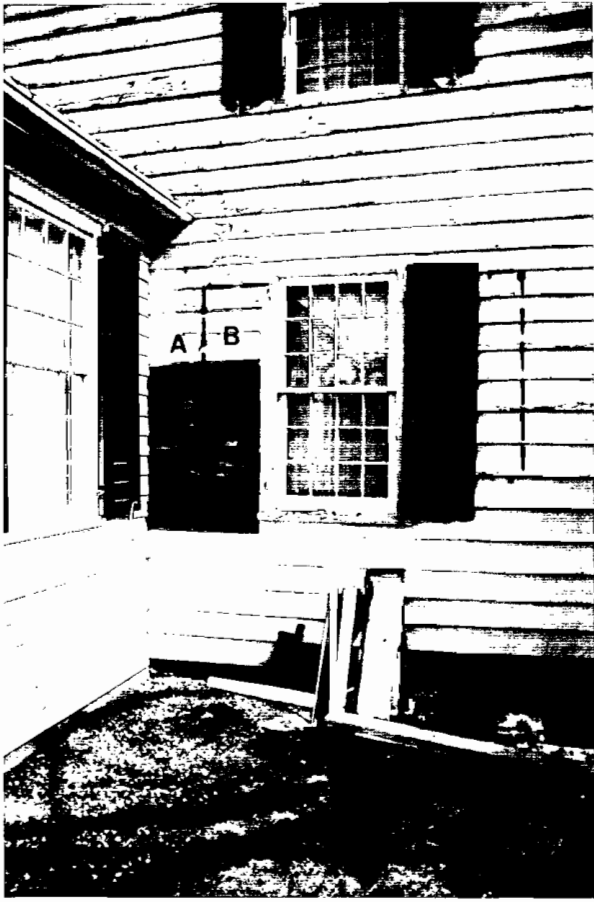
EXT - 20

Removing weatherboards along the west wall of the house also exposed earlier siding, contemporary with the original sheathing on the facade. This material is not flush boarding, however, but early weatherboards, very similar in form and dimension to the c. 1800 weatherboards which mask them (A in photos 20, 23, 27; close-up photos 22, 28, and 29). The boards are attached with rose-headed wrought nails and are as deeply weathered as those on the facade, but survive intact even on the lower stories. There is no evidence of paint even in sheltered joints.
