## EXCAVATION EXT-W2 (ORIGINAL NORTHWEST CORNER)

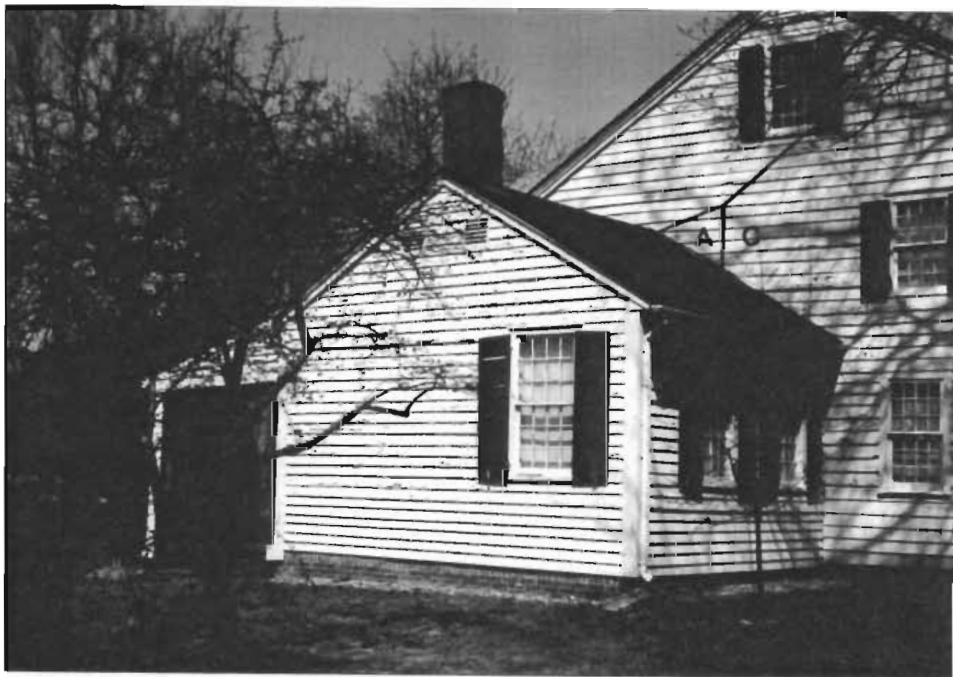
EXT - 35

The attic bisects the line between the original, early 18th century house (**C** in **photos 37 and 38**) and its lean-to addition (**A** in the same photos). The **northwest corner of the original house** is located **approximately at the black line in photo 35**.

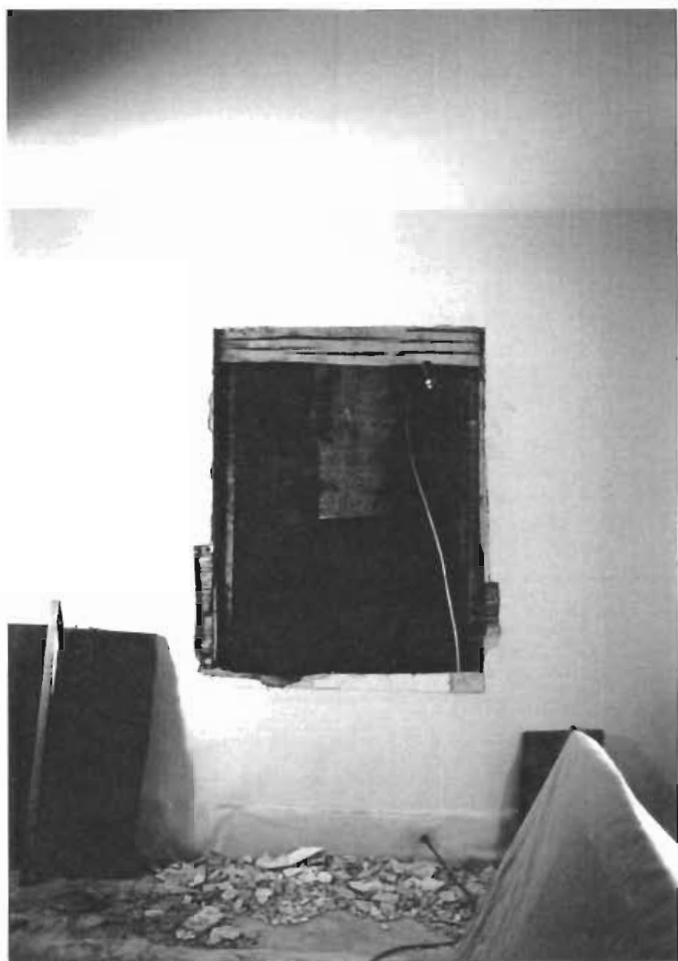
EXT - 36

A section of the house's west wall was entombed in the early nineteenth century when the west wing was raised. To gain entry to the sealed attic space, we made a hole through the wall of room 210, incidentally discovering a **window opening** likely dating to the c.1800 remodelling of the main section (the square opening in **photo 36**). The sash had been removed and the window opening blocked up when the west wing was added.
