ROOM 102

The Original Kitchen/Parlor

Fireplace evidence indicates that this room was the kitchen of the original house. The walls were sheathed with molded horizontal boards, the ceiling joists were exposed, the windows were smaller - and probably of the casement type - and there were only three doors (to the hall, the cellar, and the easterly yard).

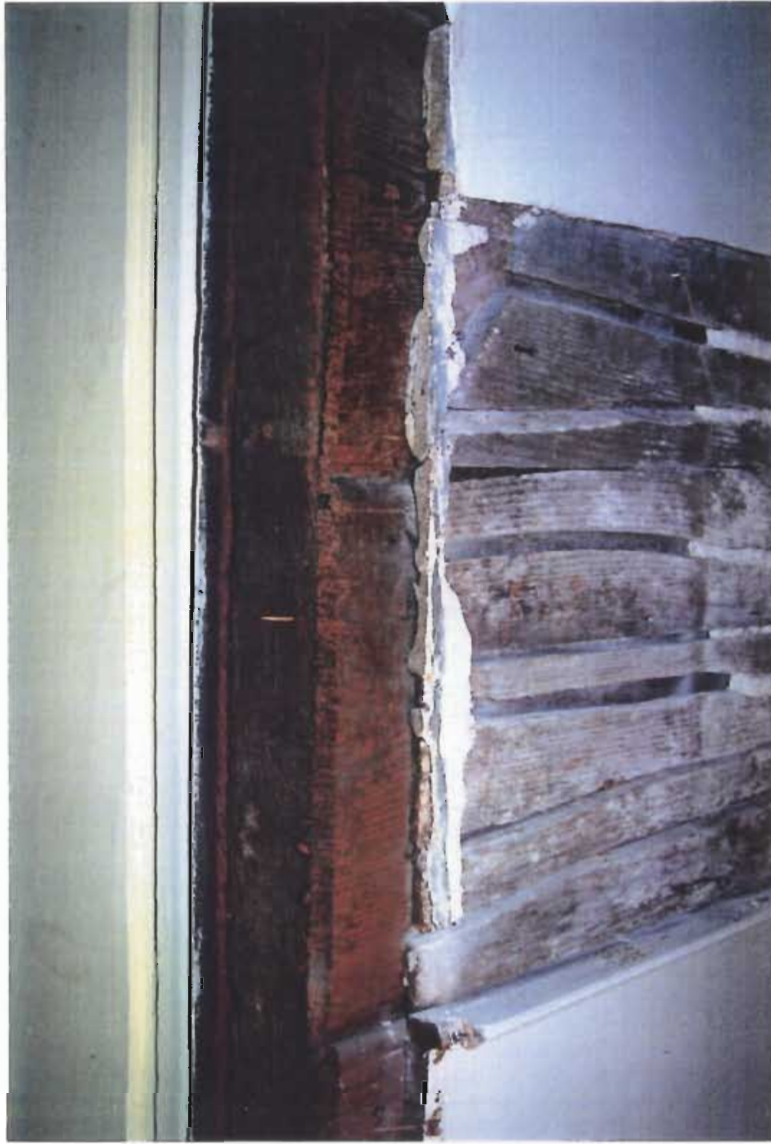
102 - 4

The room was originally sheathed with moulded horizontal boarding, a typical finish in early 18th century interiors. We found this sheathing on each of the outer (non-fireplace) walls, but the most accessible section was under the excavated kitchen door casing on the north wall (photos 4 to 6).

The one-inch sheathing boards vary greatly in width, but all are beaded and lapped on their upper edge and beveled on their lower. The boards are covered with a highly deteriorated paint layer, perhaps two coats in thickness, at least one of which appears yellow. The paint is so fragile, deteriorated, and blackened, perhaps from the cooking fireplace, that this color designation should be viewed as preliminary. Whether the paint has an oil or calcimine medium is also unclear. Crude water tests appeared to result in some solubility of the binder, but this may have been due to powdering as much as dissolution.

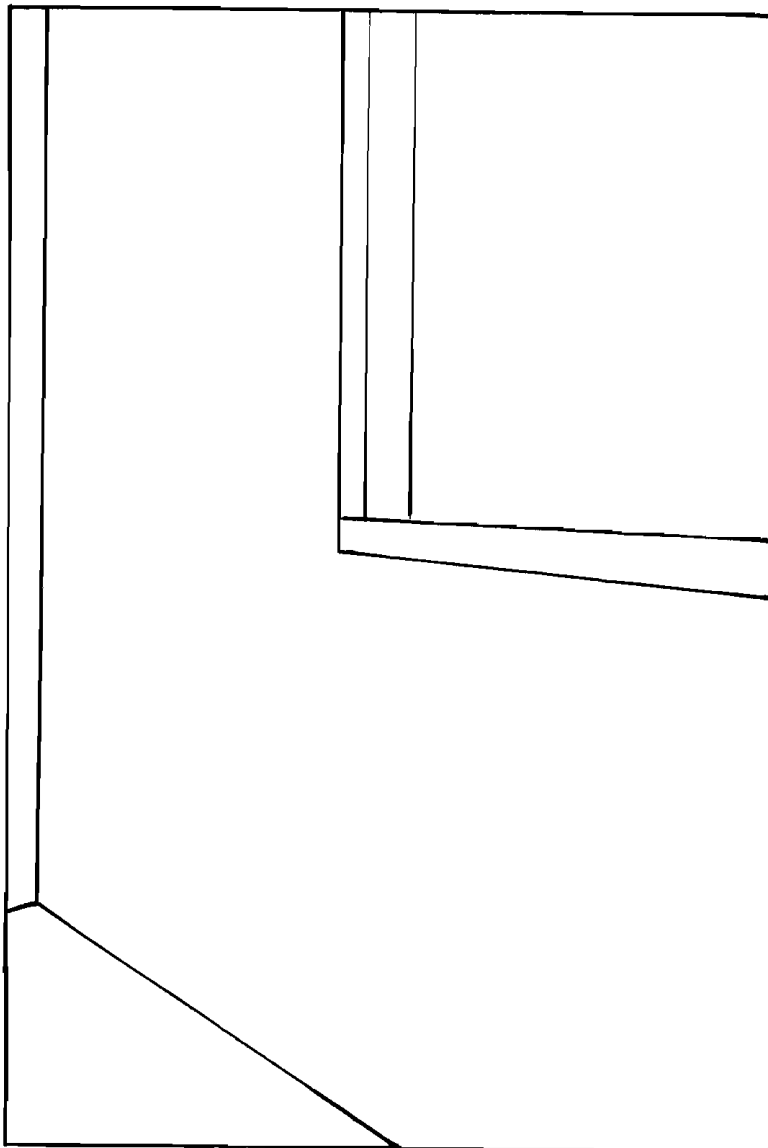
102 - 8

The present door casing is the second or perhaps third casing this opening has had. The first was probably for an original window, which was converted to a door opening when the kitchen lean-to was added (c. 1750-80). As we removed the present surround, toothpicks were pushed into each of the nail-holes associated with earlier casings. Their spacing on the right-hand stud suggests an earlier window (photos 8 and 9). The left jamb is bereft of early nail holes.

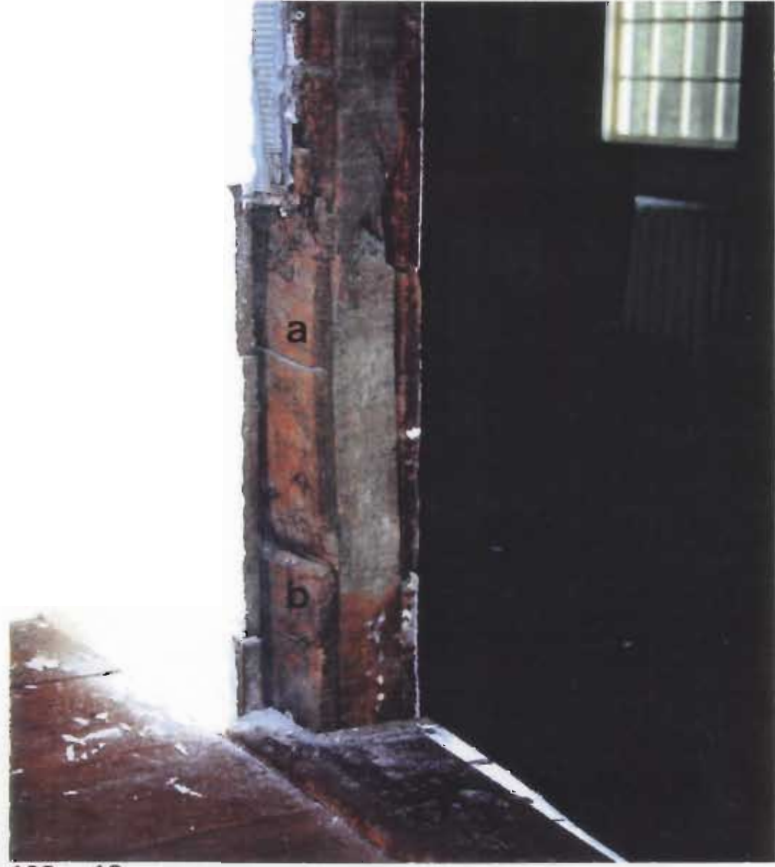
102 - 10

The nail evidence is corroborated by a cavity in the outer face of the westerly stud (photo 10) - mirrored by a smaller cavity in the easterly stud (arrow in photo 11) - characteristic of water damage just below a window sill.

A third piece of corroborating evidence are the two sheathing boards below the rotten areas on either side of the door frame (a & b in photos 10 and 11). These appear to have once spanned the opening, while the sheathing boards above and to either side of the door do not align.

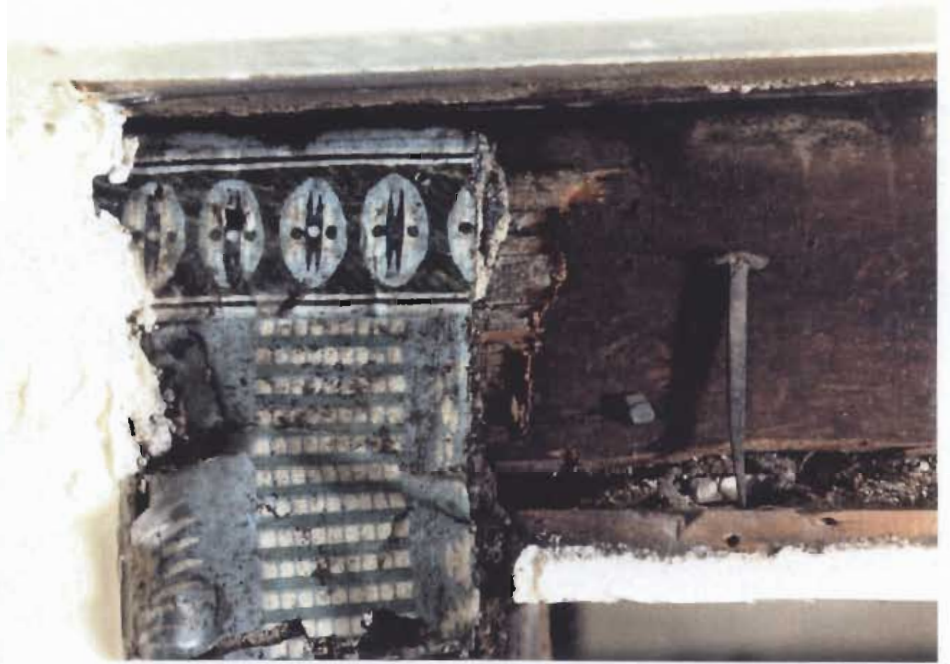
102 - 12

Behind the kitchen door casing, we discovered a long strip of blue wallpaper, laid directly over a bright blue distemper wall-paint (photo 12). The blue wall-paint survives on the original c. 1800 plaster at many points in the room, but the samples preserved under this and other wallpaper fragments (see photo 16) were particularly fresh. Large areas of this paint could be exposed to the left of the door casing by simply removing a later plaster skim-coat.

The blue wallpaper seems to belong to the second Federal-period finishing scheme. The strip trapped behind the later door casing extends from the chair rail to the ceiling (56"), and incorporates border fragments (1-11/16" wide) at each extremity. There is a 10" wide bulge in the center of the fragment which was covered by a later plaster skim-coat (A), and is severely bleached.

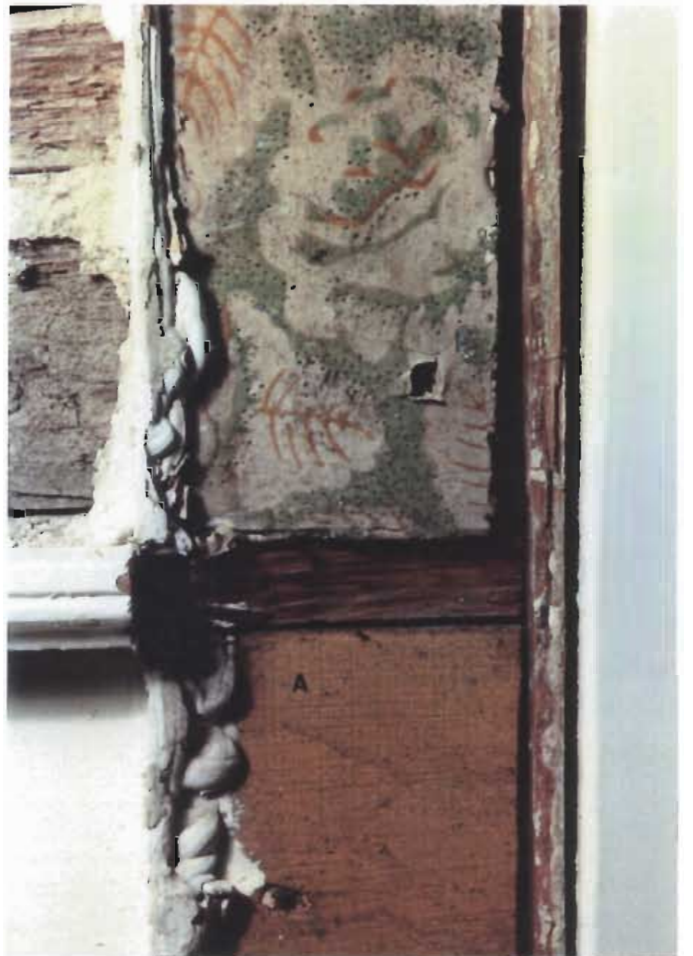
102 - 17

Microphotograph of paint cross-section taken from "A" in photo 102-17 (area of varnished casing covered by door casing). The actual colors are darker than they appear.

The door casing also covered a strip of wainscot, preserving a deep yellow woodwork paint which must have accompanied the green paper (**A, the attached color chip represents a close match**).

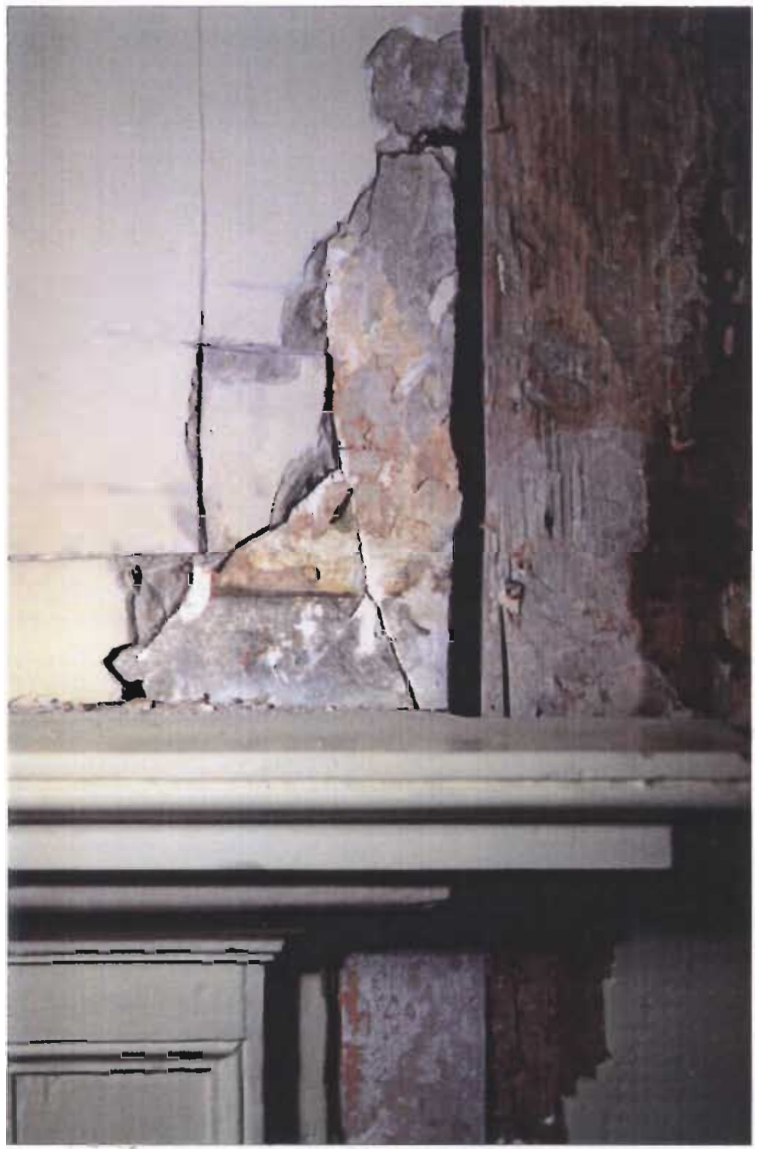
102 - 19

In removing a plaster skim-coat at the right-hand end of the mantel, we discovered one corner of a now-destroyed overmantel painting (photos 19 and 20). The painting was executed in distempers on finish plaster, and was likely contemporary with the Federal mantel and blue wall-paint. All that remains is a fragment of the grey border (C), a dark green/grey line separating the border and field (B), and a small area of the field itself (A). The painting was later covered by repeated applications of wallpaper, of which a few small fragments survive.

The bulk of the design was lost in the 1950s when an excavation was made above the mantel to access the fireplace. Extremely hard replacement plaster (the material to the left of the fragment) was used to fill the opening.

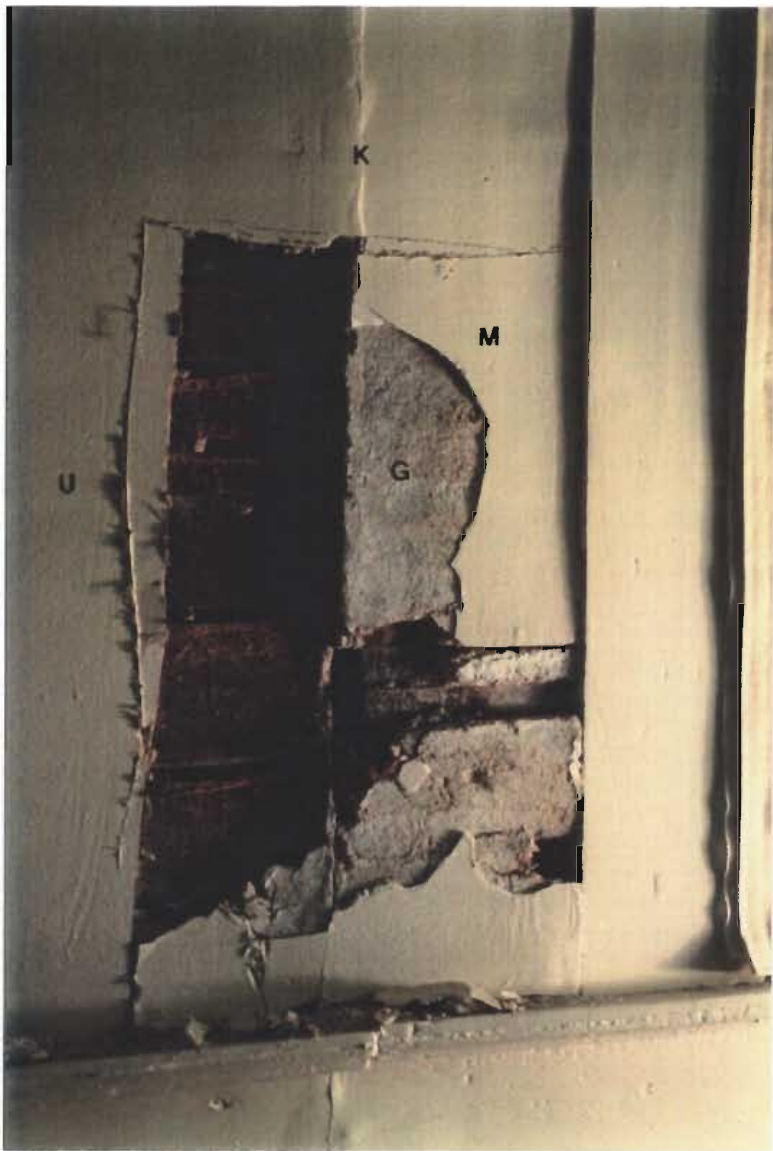
102 - 24

The area between **K** and the present door is bereft of horizontal wall sheathing, and filled with split-board lath held by cut nails (**U** in photo 24). An excavation made into this same area from the exterior (**EXT-E**) found nineteenth century sheathing boards and nails instead of eighteenth century siding.

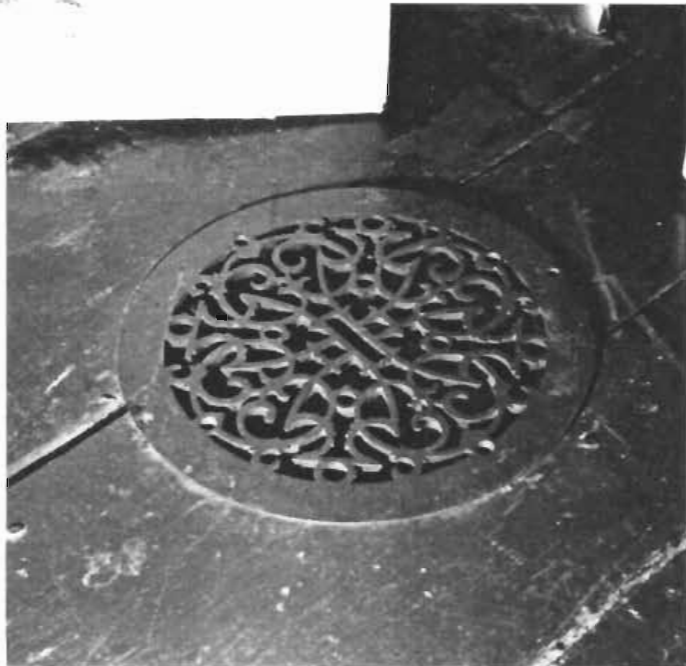
102 - 29

A few of these joists can be examined through metal grate-holes in the floor of the chamber above (photos 29 and 30). Both the joists (J) and the undersides of the chamber floorboards (C) are covered with a thick, white, water-soluble paint, likely a distemper. A similar or identical paint covered the exposed joists in the adjacent kitchen. The summer beam was undoubtedly painted in the same way, but the finish was long ago removed. The back side of the later lath is also visible in the photograph (L).

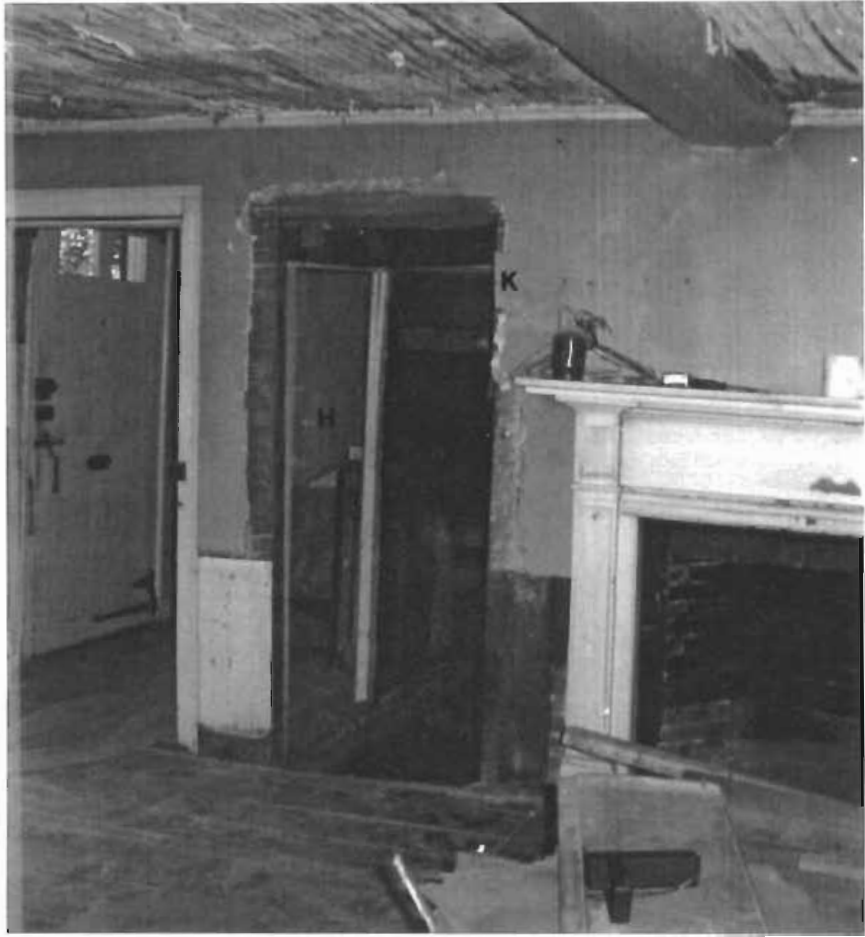
102 - 33

The present cellar door opening (**K**) was discovered within a wall cavity during the restoration work of 1981 (photo 33, shows the door after it had been opened). Prior to 1981, the cellar was entered through a door from the front hall (**H** in the same photo). The restorers closed up the hall opening and inserted an early nineteenth century door (probably from elsewhere in the house) into opening **K**.

The physical evidence in this area is greatly disturbed, but it seems probable that **K** was the original (c.1725-35) cellar door, connecting the cellar with the original kitchen. Just as probably, **K** was closed up, and the cellar stair re-located to the front hall (**H**) c. 1800, when the old kitchen became a parlor and the present hall stairs were constructed. The restorers likely erred, therefore, in putting a Federal-style door and casing in an opening that had actually been closed-up in the Federal period (drawing 34).
