## ROOM 109

### The Kitchen

## Kitchen Woodwork

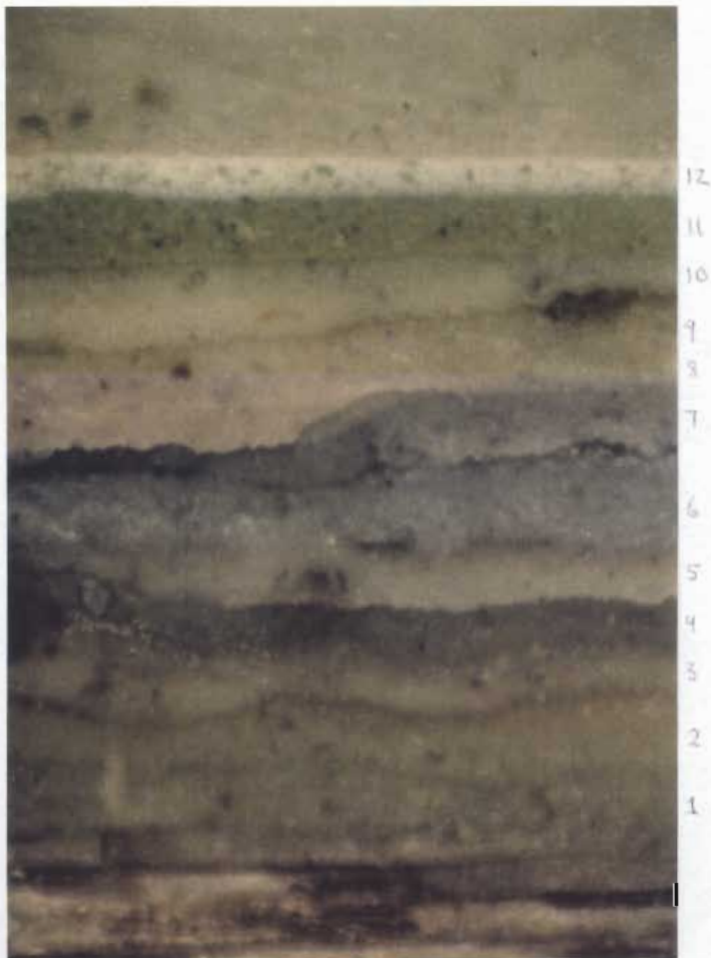
Microphotograph of paint cross section from the kitchen side of the door to Room 112. The dam is the only kitchen woodwork feature which escaped stripping.

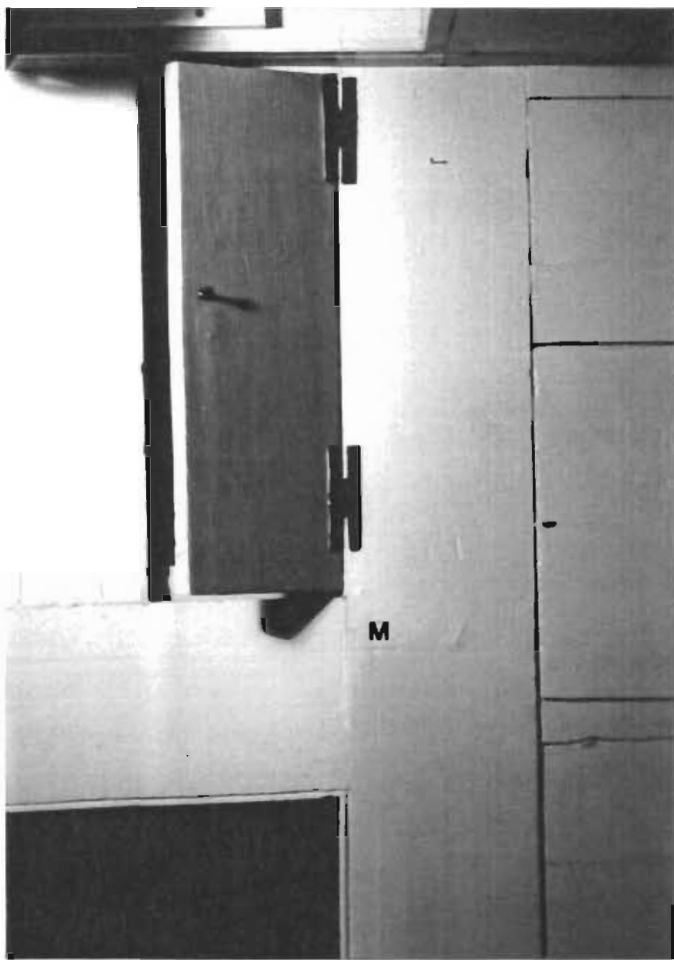
109 - 2

The small cupboard and door above the fireplace (photo 2) appear to be early and virtually untouched. There was a mantel just below this cupboard (at M), which is also visible in 1970s photographs (no. 1 & 6) but was later removed.

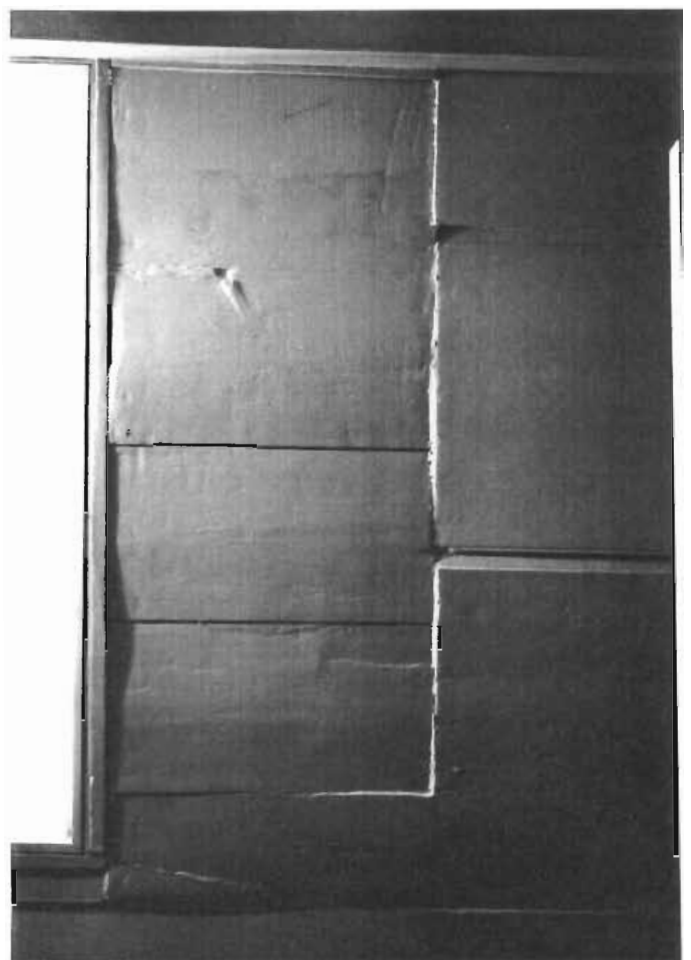
109 - 3

The most obvious alteration is the closing in of an early window opening (photo 3) next to the present north window, <sup>which</sup> must have related to a space-usage problem. The new window was covered with a sliding shutter, which we know only from a 1976 photograph (no.7).

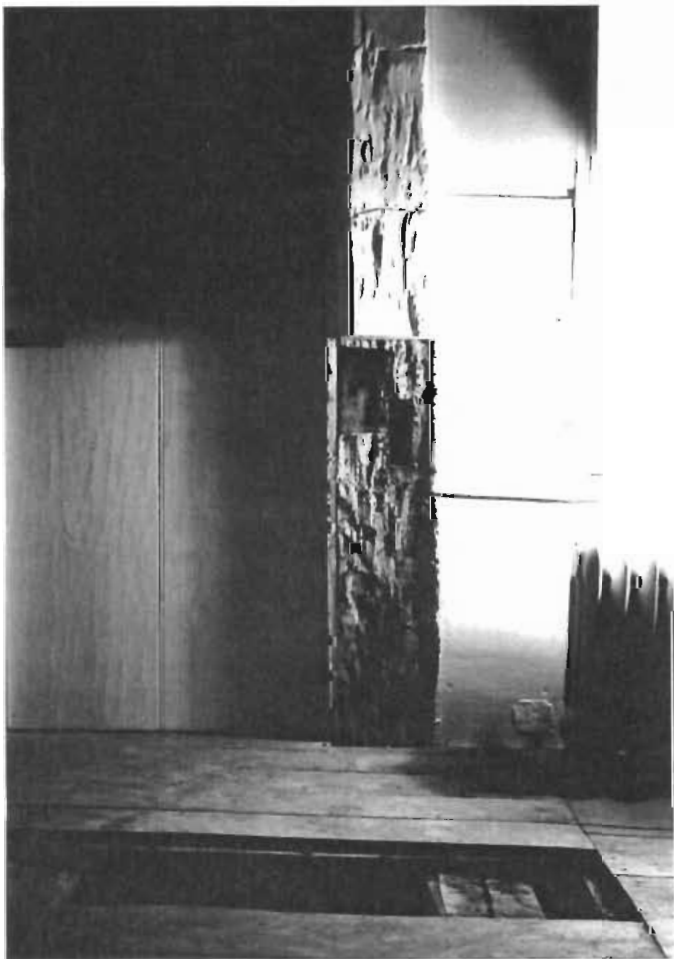
109 - 4

We removed a board which was covering the lower half of one of the kitchen posts (photo 4) exposing its rough surface. The post had two mortises cut into it, neither of which correspond with the nearest floor joists, indicating it was re-used from another structure.

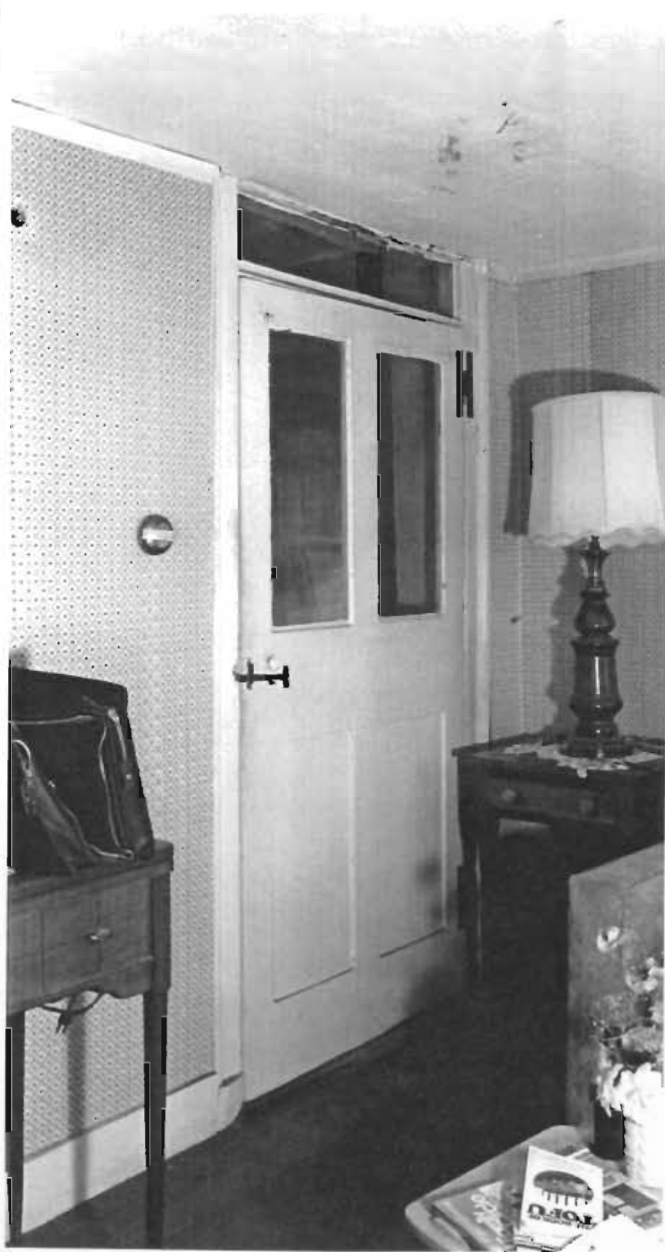
109 - 8

The partitions enclosed a staircase (**A**), a corridor linking the kitchen and room 102 (the old kitchen) with the ell (**B**), a bathroom (**C**), and a closet (**D**). The staircase and the door to the ell (**E**, and **photo 8**), at very least, are contemporary with the ell. We have too little information about the two closets/rooms to evaluate their age.

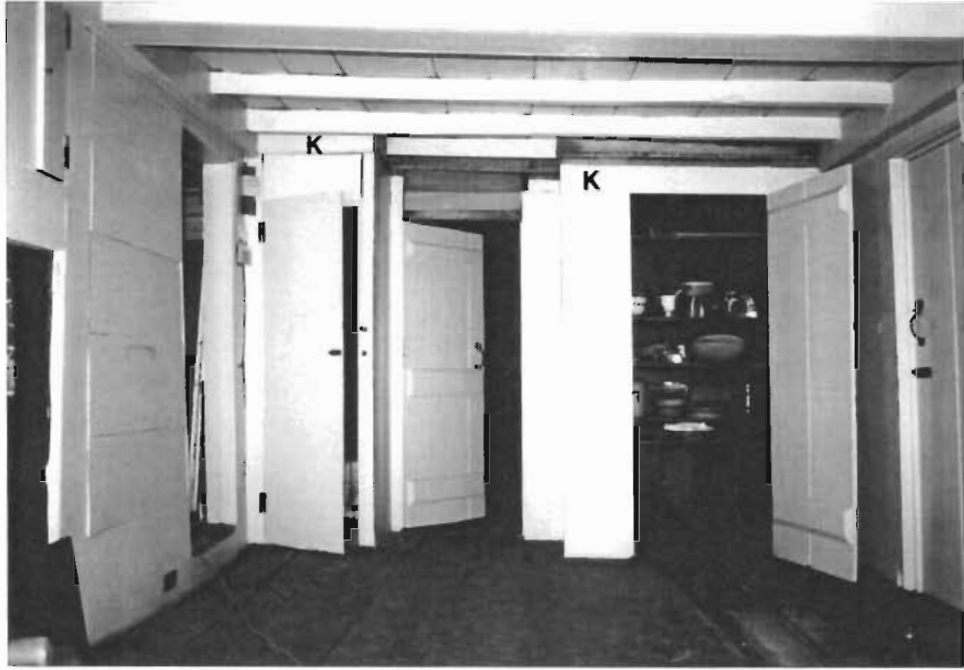
109 - 10

- The partitioning and cupboards were built under an existing ceiling of split-board lath and plaster. This was revealed by stripping away some rake boards applied in 1953 to access two cavities above the cupboard and cellar stairwell (**K in photo 10**). The plaster ceiling (**P in photo 14**) extended across the whole room prior to 1953. Its underside was still covered with calcimine paint (color chip --) applied before the partitions were constructed in the early nineteenth century,

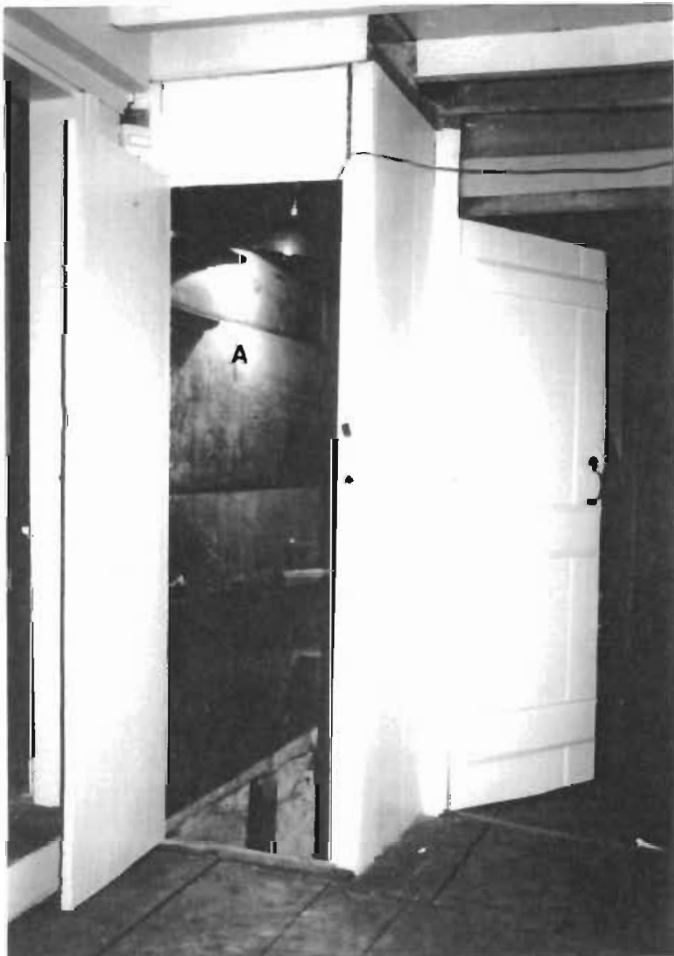
109 - 11

- The horizontal boarding on the south wall of the cellar stairwell (**A in photo 11**) is painted yellow. These same painted boards form the back wall of the cupboard in the buttery (**photos 110-6**). Virtually identical boards run along the north wall of both rooms. These are also painted where they run through the kitchen cupboard (**B in photo 12**).

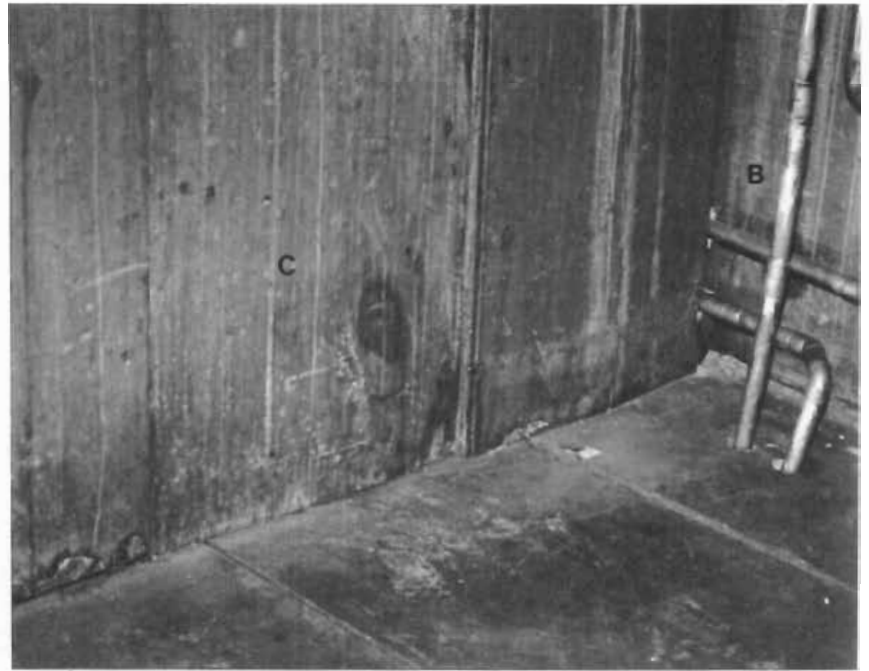
109 - 12

- The back wall of the kitchen cupboard (**C in photo 12**) is made from re-used, painted sheathing boards, now vertical, but perhaps horizontal originally.

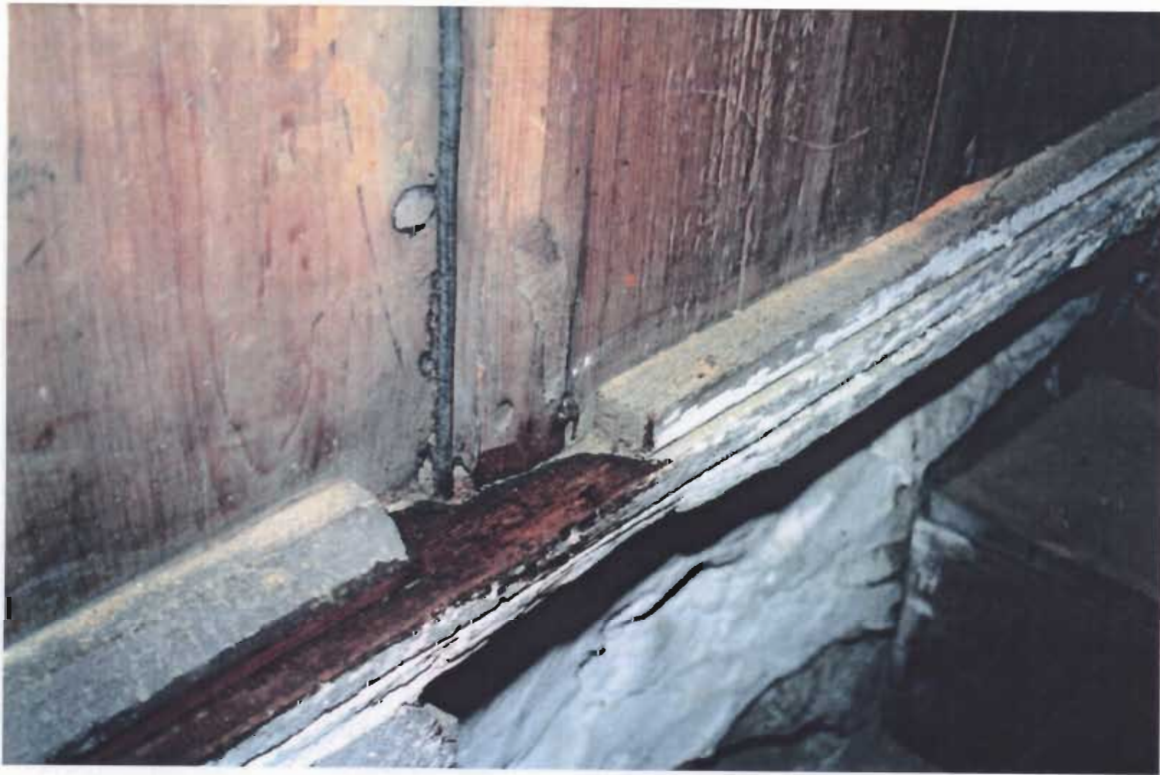
109 - 13

- The kitchen floorboards were clearly sawn through to create the cellar stairwell. The edges of the boards within the stairwell retain small fragments of yellow floor paint, doubtlessly applied before the stairwell was constructed (**A in photo 13**).

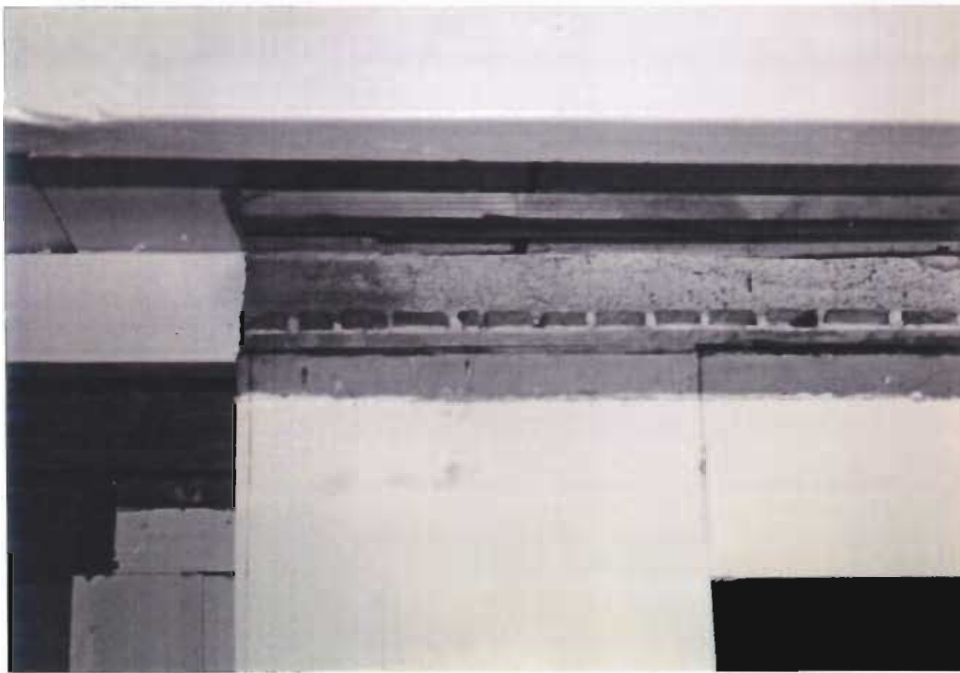
109 - 14

Above the plaster ceiling, the joists and ceiling boards were still covered with white water-soluble paint, probably distemper (**D in photos 14 and 15**) (color chip no.--). This was probably applied in the 18th or very early 19th centuries. Small sections of the wall sheathing, also sealed within these cavities, were covered with an ochre-colored distemper.
