## ROOM 112

### A Parlor or Chamber

## EXCAVATION 112-A

### Early 18th Century Wall Plaster and Finish

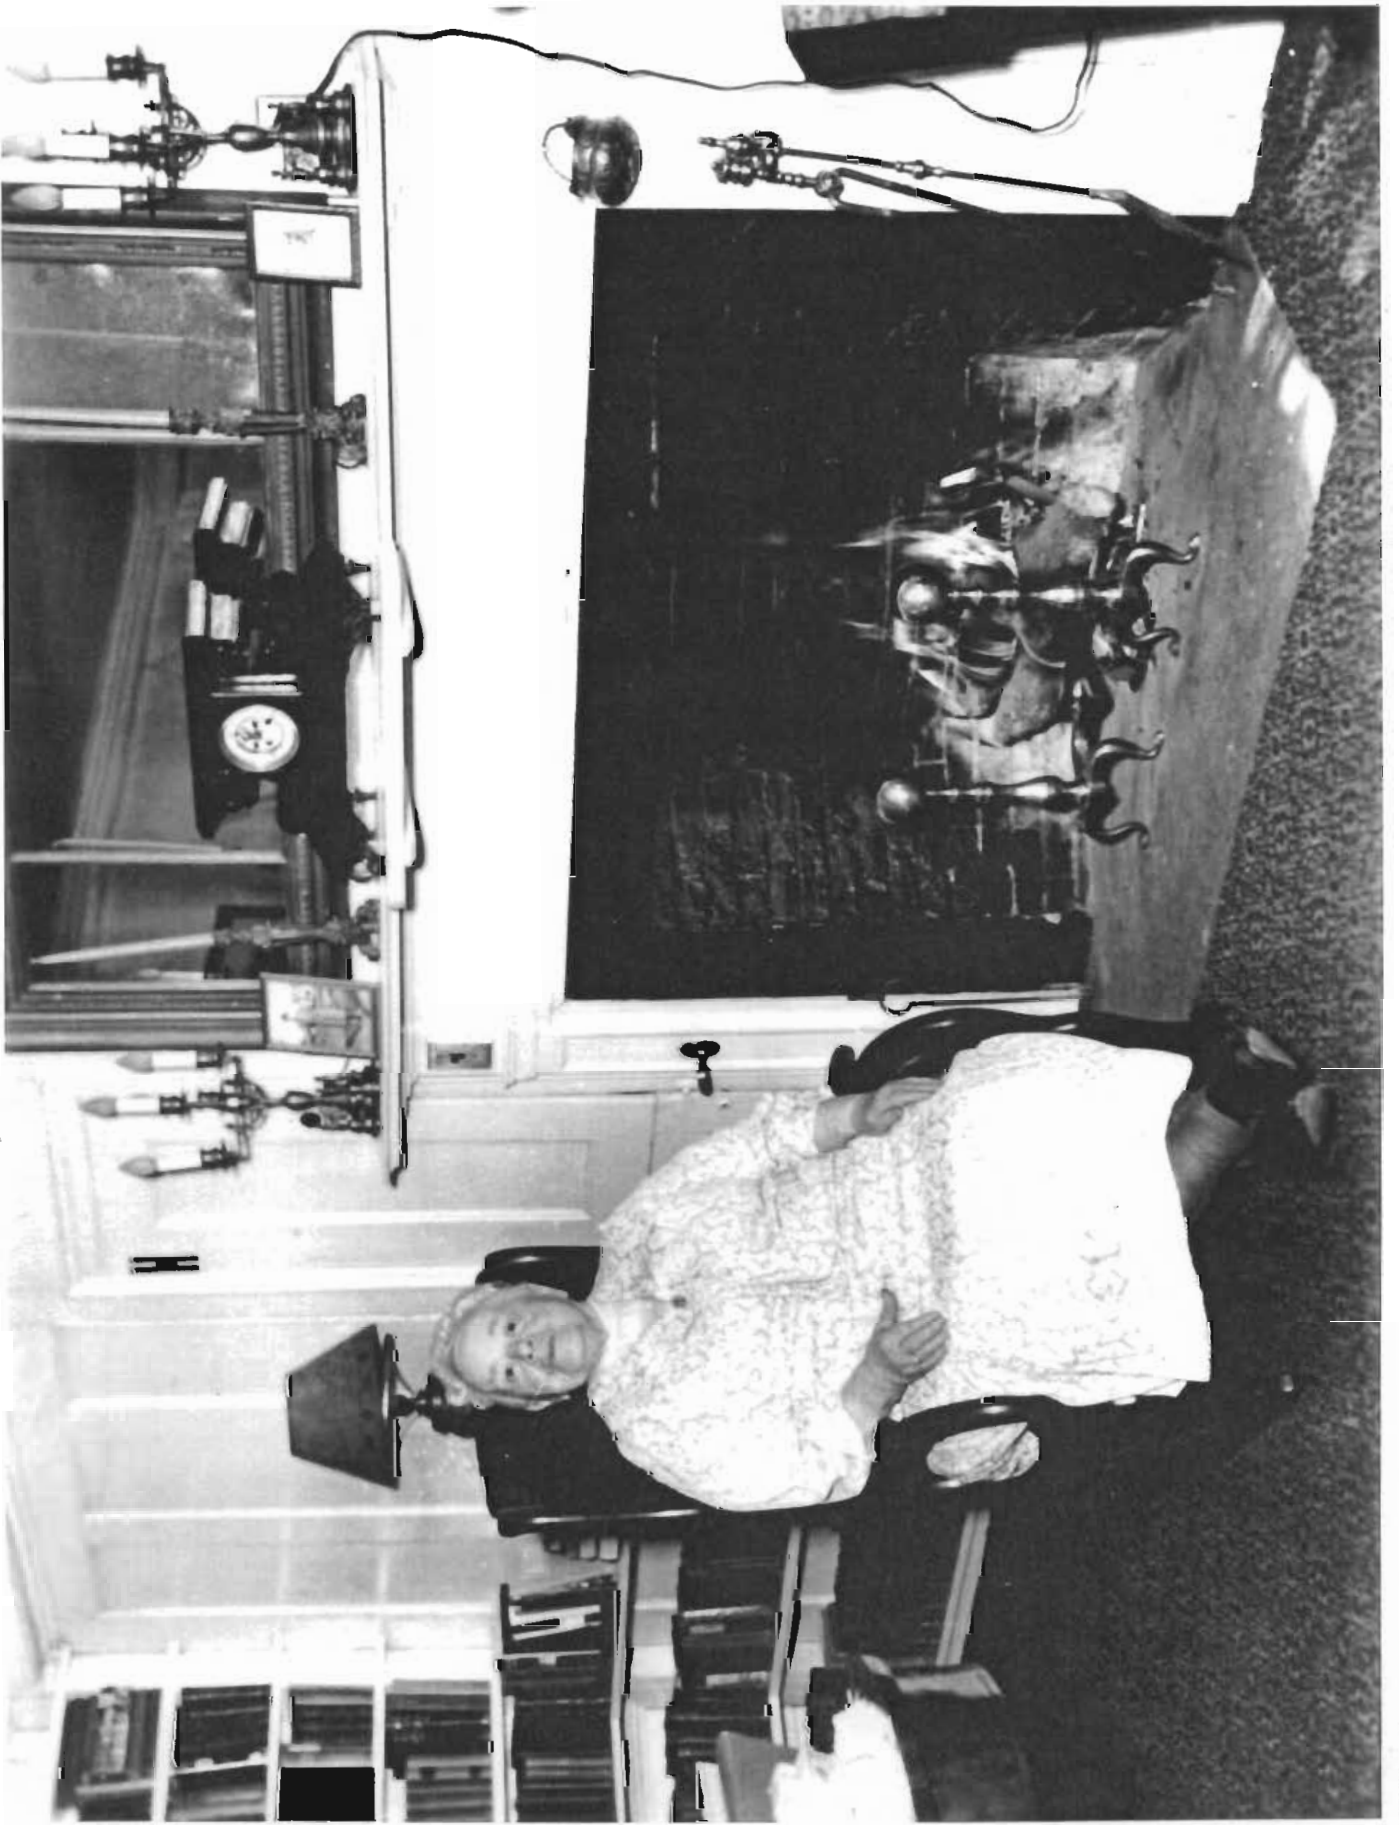
This photo shows the room during the last few years of its occupancy by Anna Bliss. Miss Bliss believed the house to date to the mid-17th century and left it to the Northampton Historical Society as a shrine to Joseph Parsons, a founder of Northampton and its supposed builder. Ms. Bliss' arrangement of the room, and presumably the other rooms as well, was in no way extraordinary for the 1940s, and made little or no attempt at historicism.

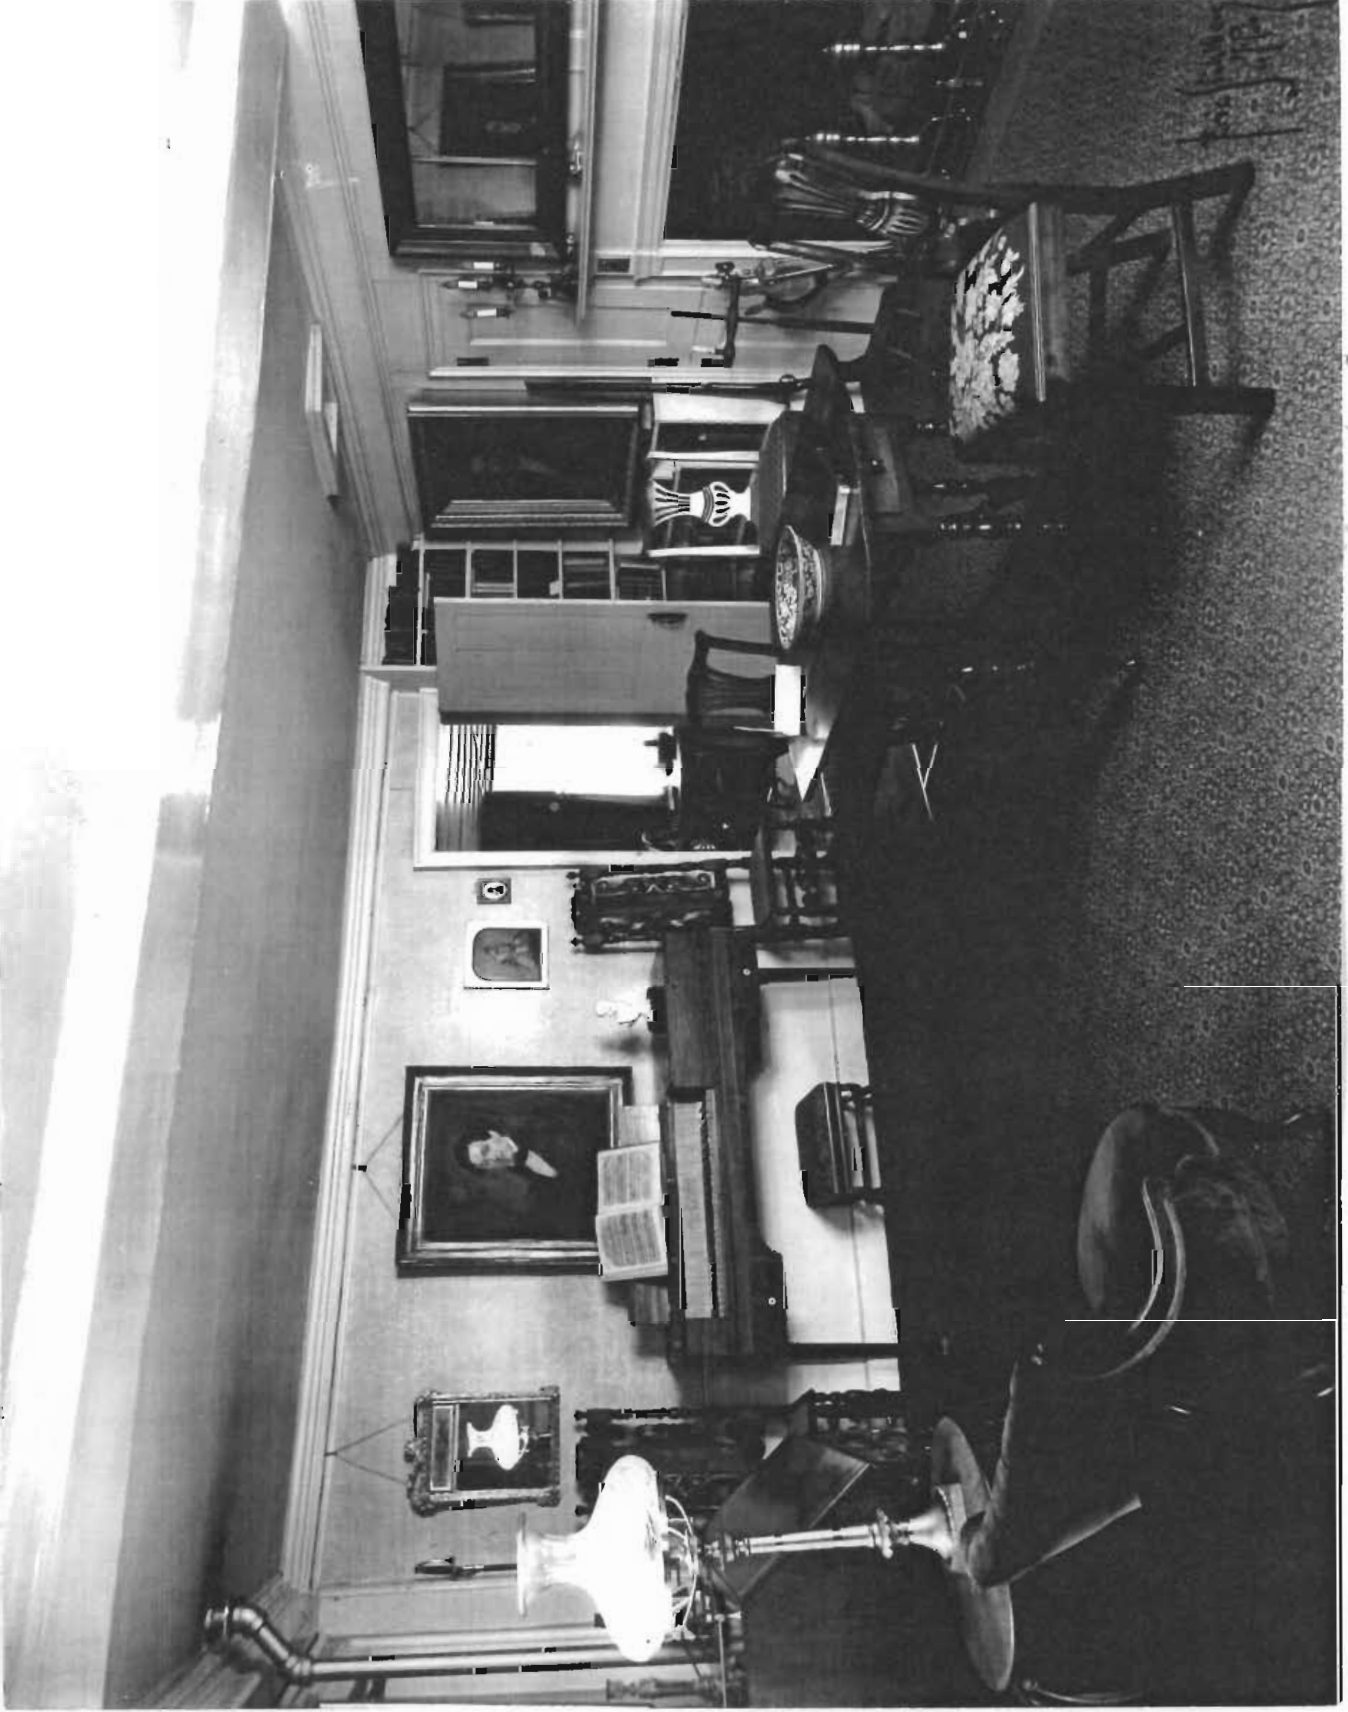
Parlor. Cornet Joseph Parsons House - 1658 / (Print 1000 Cards)

This view was taken shortly after Miss Bliss's death, when the room had been redecorated in an historically-derived style by the Northampton Historical Society. The architectural finishes, the carpeting, and many other contemporary features, such as the drain pipe to the extreme left, remain in place. All of the changes are to the movable furnishings, Miss Bliss's simple rocker giving way to a collection of mostly 18th century furniture, probably donated from area attics.

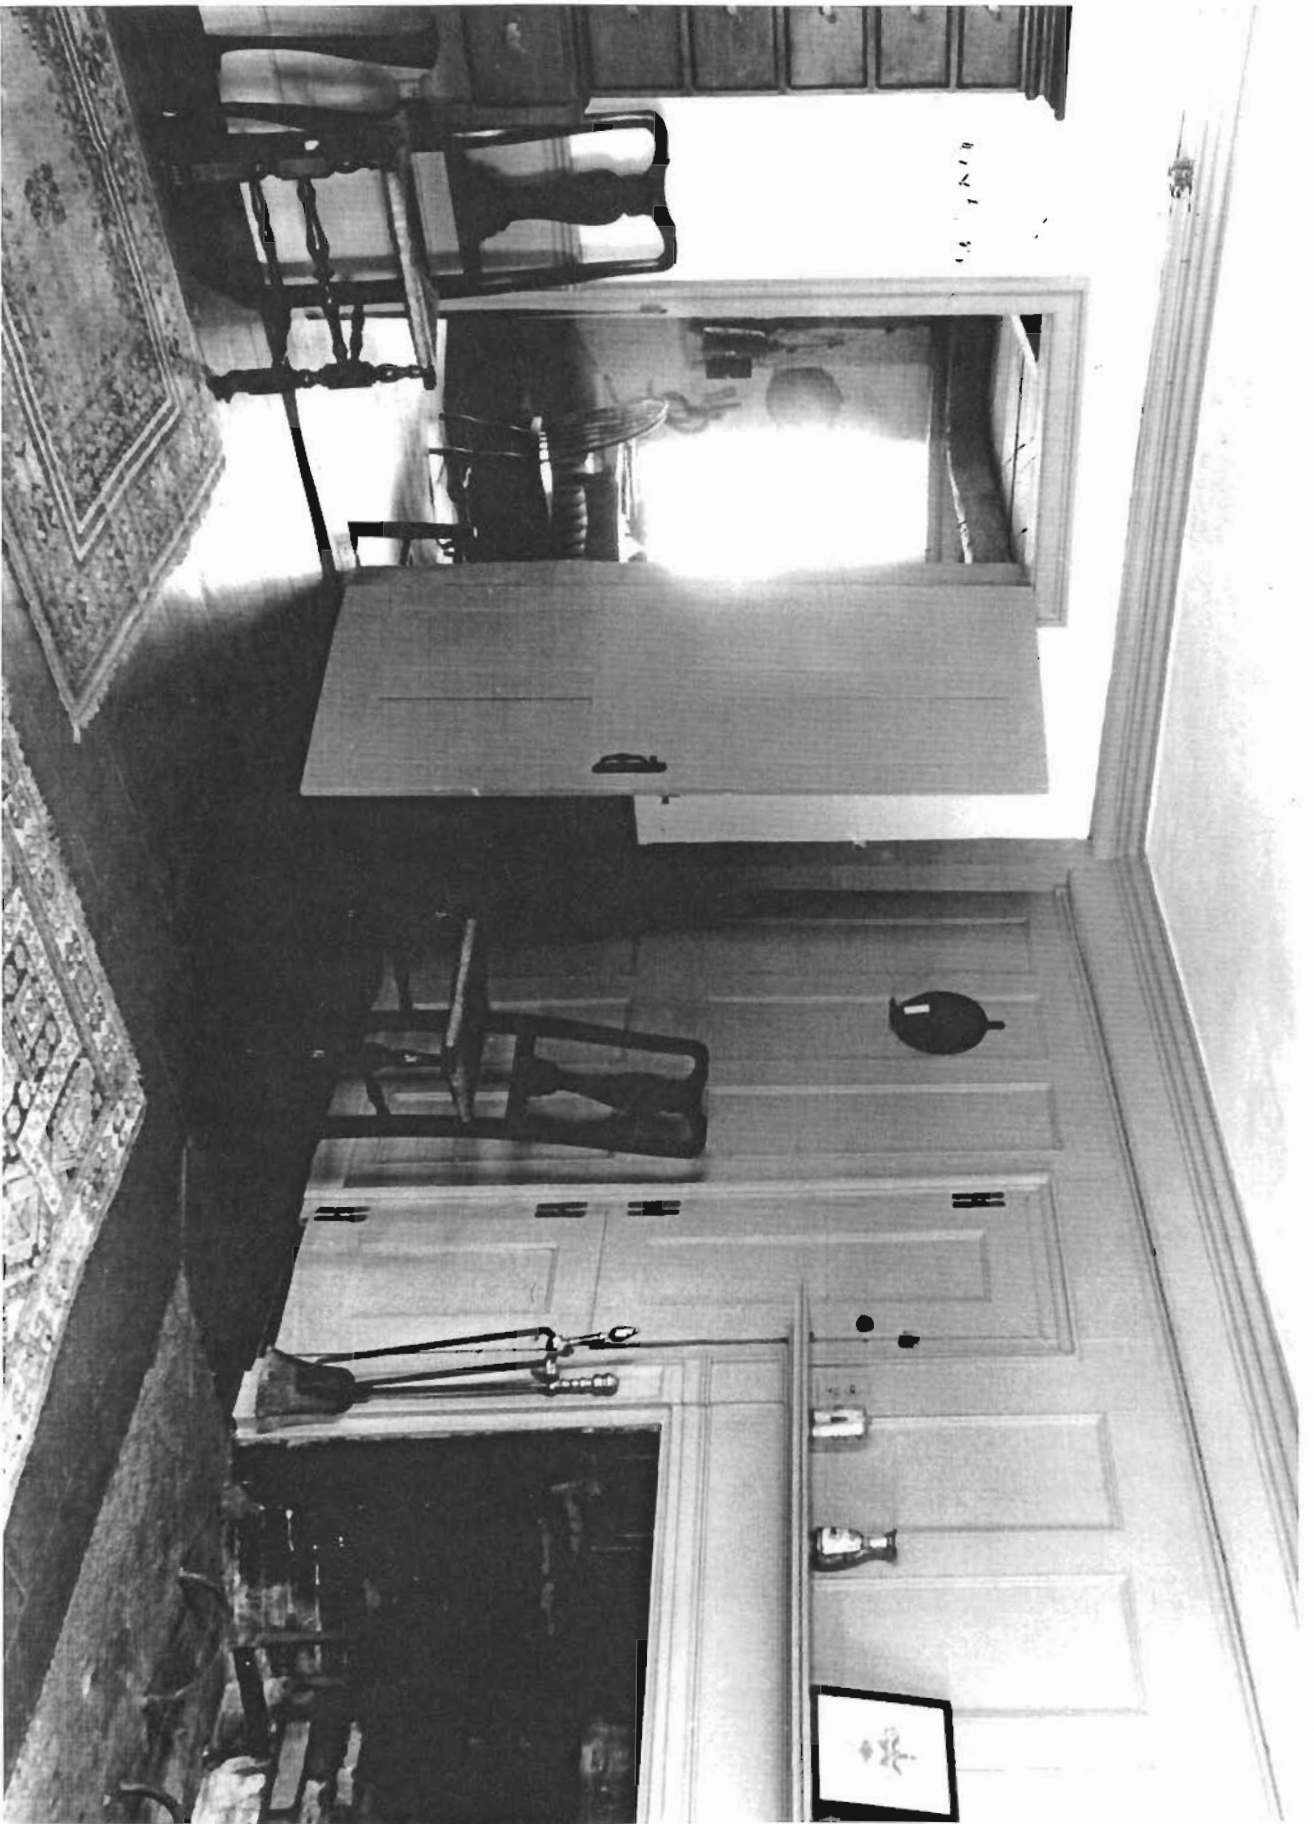
By this time most of the furniture was gone, replaced with a few consciously simple pieces, but the architectural finishes had been brought into the interpretive scheme. The woodwork was colored, the walls given an imitation whitewash finish, and carpet stripped away to expose the floorboards. The room has a look consistent with museum scholarship of the time, though, still, neither the furnishings or finishes derive from a physical or documentary investigation of this particular space.

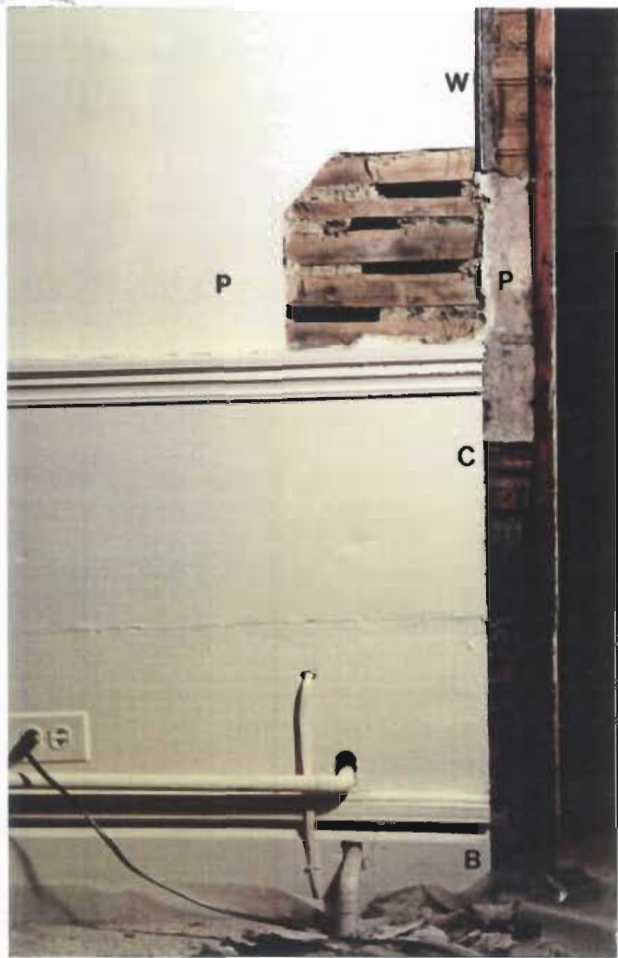
112 - 4

This excavation revealed that large areas of the west wall retain an archaic plaster (P), perhaps as early in date as the house itself (before 1735). Our initial cut into the plaster (photo 4) uncovered riven lath, the standard lath type in New England until the last quarter of the 18th century. We continued the excavation to the left (photo 9), locating wrought nails at the fastening point between lath and studs (R in photo 8). A piece of the Federal-period wainscot was also removed to reveal the surface of the early plaster (photos 9 & 10). Early plaster is presumably entombed behind the wainscot for the whole length of this wall.

The original finish scheme included a chair rail (**C in photos 4 & 6**) and a simple baseboard (**B in photo 4**). The chair rail originally had a projecting, molded nosing, which was removed to provide a flat underlayment for the wainscot. The empty nail holes for the nosing are still visible. The woodwork shows no sign of having been painted. The exposed end of the baseboard is clearly without paint. It will be important to examine the entire length of this wall after the wainscot is fully removed (see **Interpretation section**).

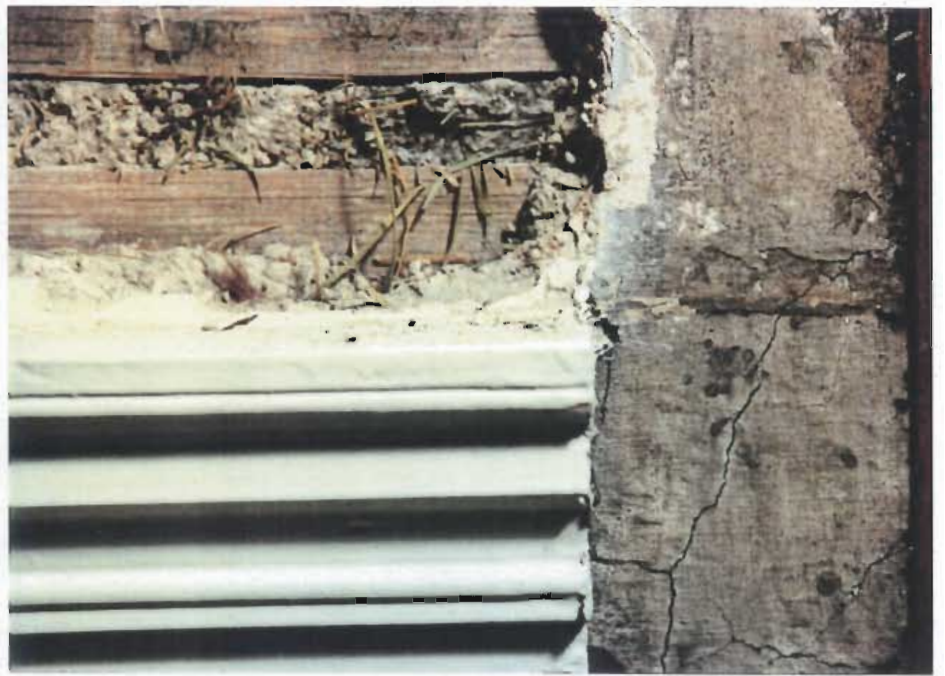
112 - 5

This plaster surface presented a number of surprises. The plaster itself is bound together with grass, clearly visible in photo 5, and thin textile fibers, only visible under the microscope. These are very unusual binding materials, with which we have had no prior experience.

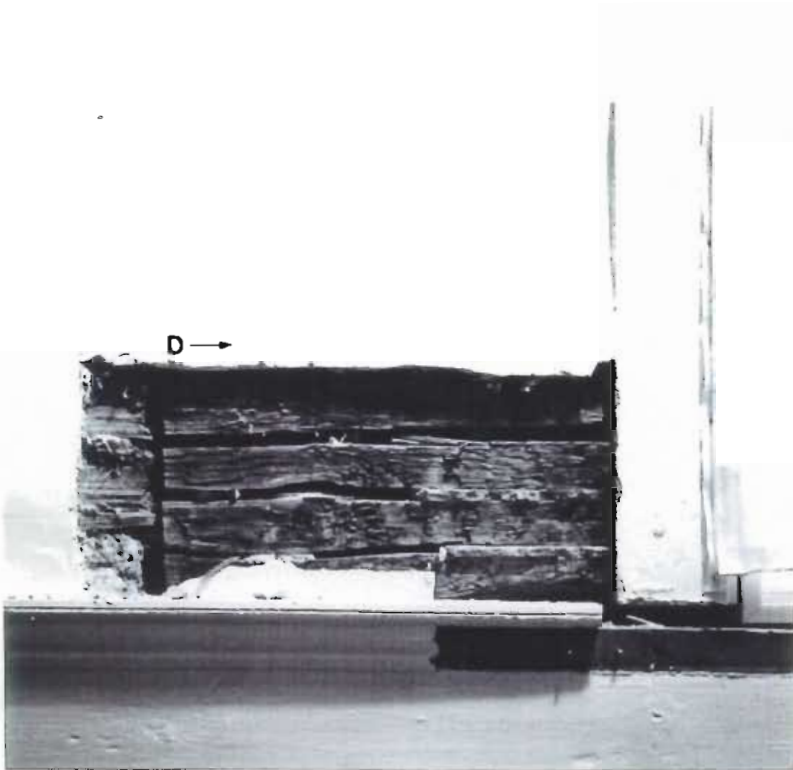
112 - 7

A bank of casement windows likely occupied the center of the west wall from the early 18th century until the Federal-period remodeling (the dotted line on the elevation drawing). The present sash window is flanked on both sides by split-board lath fastened with cut nails, (**D** in photos 7 & 9). This describes a 5' wide window opening reduced and filled in during the Federal-period remodeling. We did not fully excavate the opening, but infill of the same period was found on the exterior. A similarly sized opening was located in the chamber directly above. (See excavations EXT-W and 210 W for a fuller discussion of the original fenestration.)

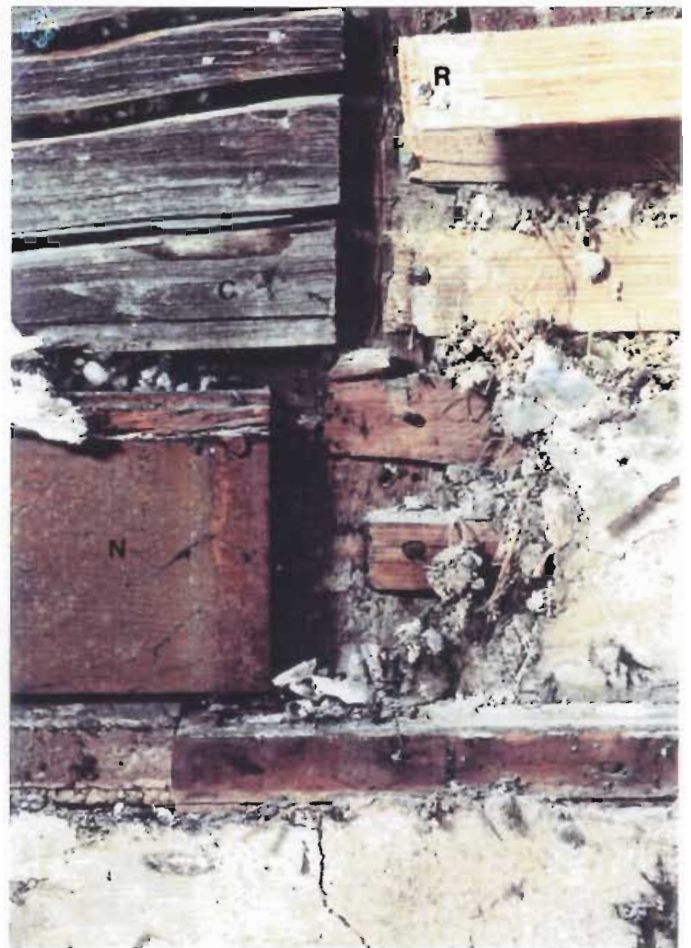
112 - 8

The split-board lath infill to the right of the present casing (**C** in photo 8) is re-used exterior window molding, part of the house's original siding scheme (c. 1725-35). Similar material was re-used as lath in other rooms.

The painted board below the window (**N** in photo 8) was installed as a nailer for the wainscot earlier in this century, when the wainscot was temporarily removed and re-nailed. It is fastened with wire nails.

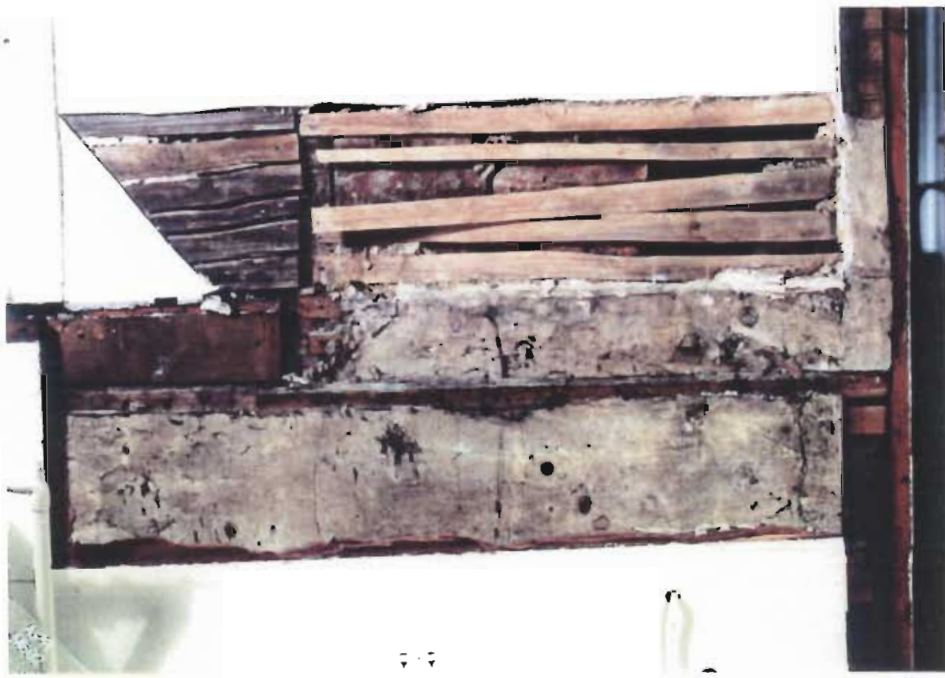
112 - 9

The wall cavity behind this early plaster is filled with nogging - bricks laid in clay mortar (visible in photo 9) (see excavation **EXT-W** for a fuller discussion).

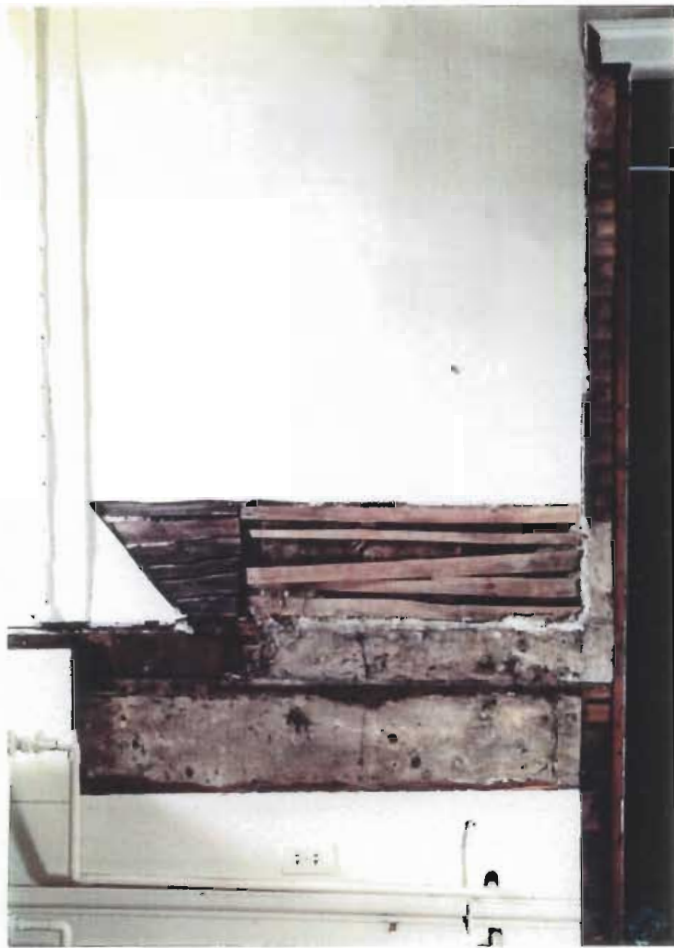
112 - 10

Drawing II describes how the section of wall in photo 10 might have appeared in c. 1725-35. The size and arrangement of the window panes is the only conjectural feature.

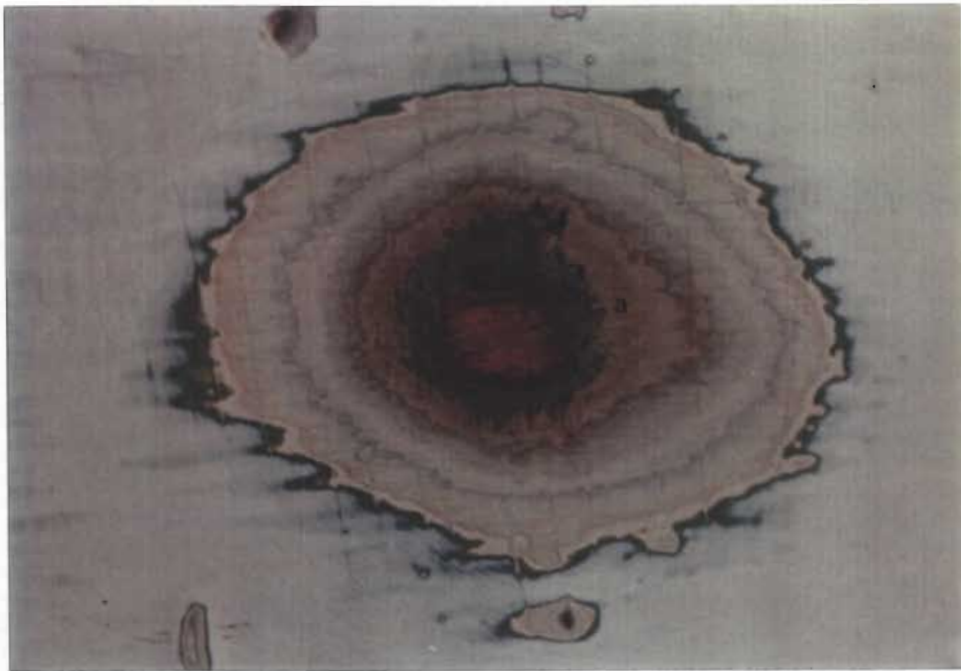
112 - 14

The wallpaper likely accompanied a deep yellow paint layer on the woodwork ("a" in photo 14, which shows a "crater" made in the paint film of the wainscot). This yellow is the third Federal-period woodwork color, and was the first layer on the present mantel.

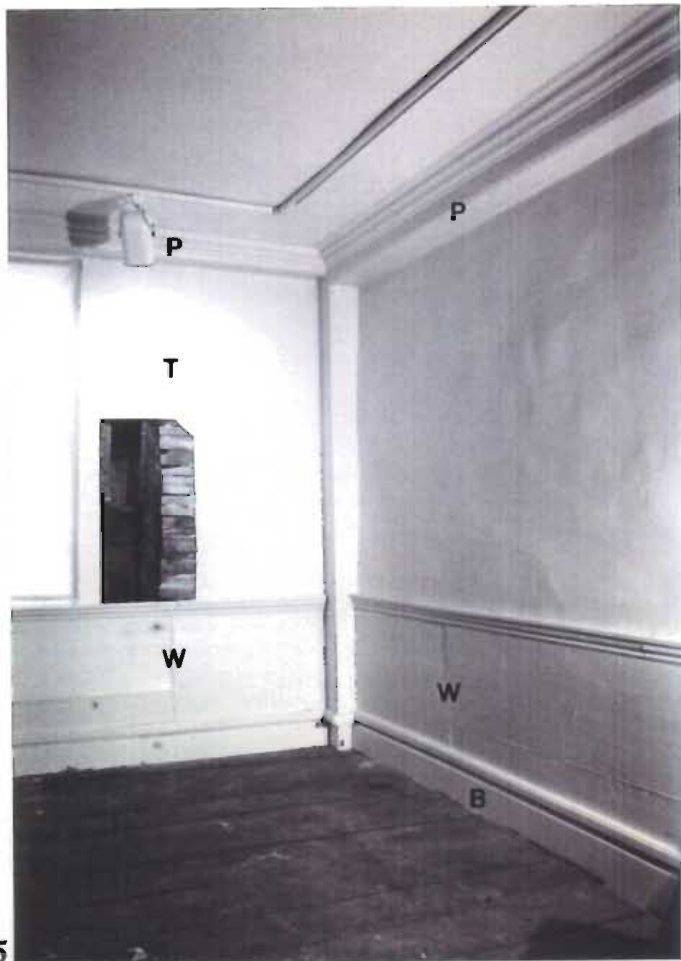
2 - 15

- Fragments of wainscot, chair rail and baseboards have been pieced into this corner on both sides of the post casing (inside of the lines marked W in photo 15). The baseboard on the west wall (**B**) is the exception - this seems to have been removed and replaced when the present floor was laid in the 20th century. Paint analysis confirms that the woodwork closest to the corner is later infill. In other words, the wainscoting did not originally extend into this corner.

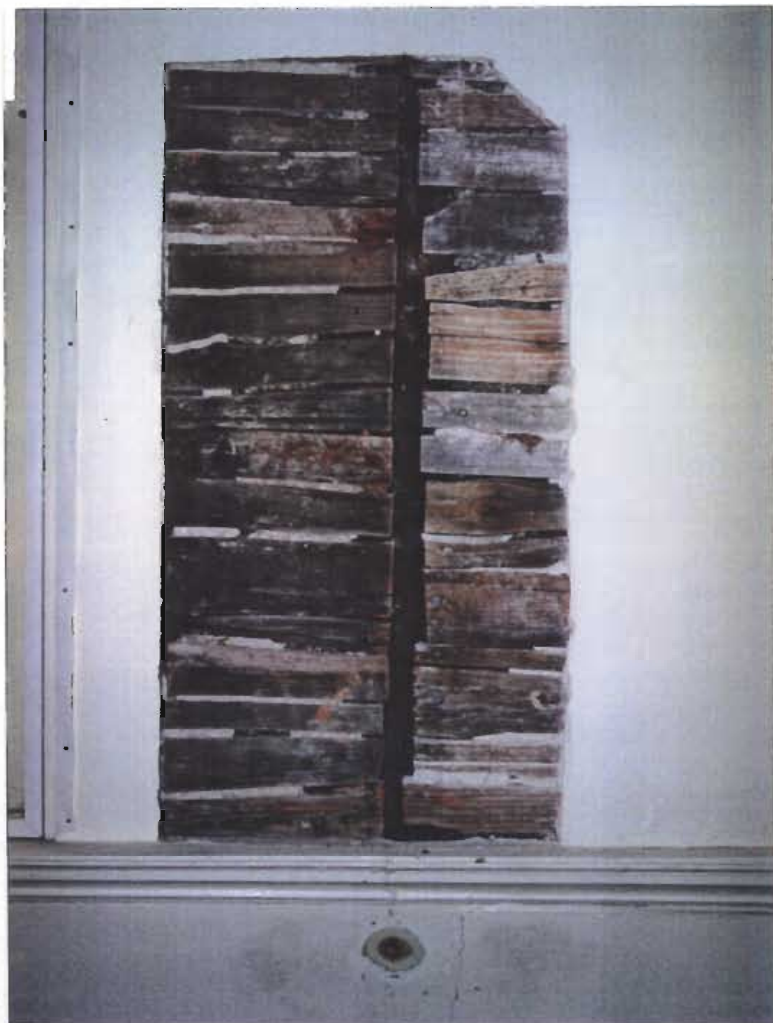
2 - 17

- The break in the woodwork on the south wall corresponds with a plaster line (**T**) extending to the girt casing. Our excavation along this plaster line (**photo 17**) revealed two distinct periods of split-board lath, both held (predominantly) by cut nails. The manner in which the two plasters overlapped at the joint indicated that the lath closest to the corner was later infilled, like the wainscot below.

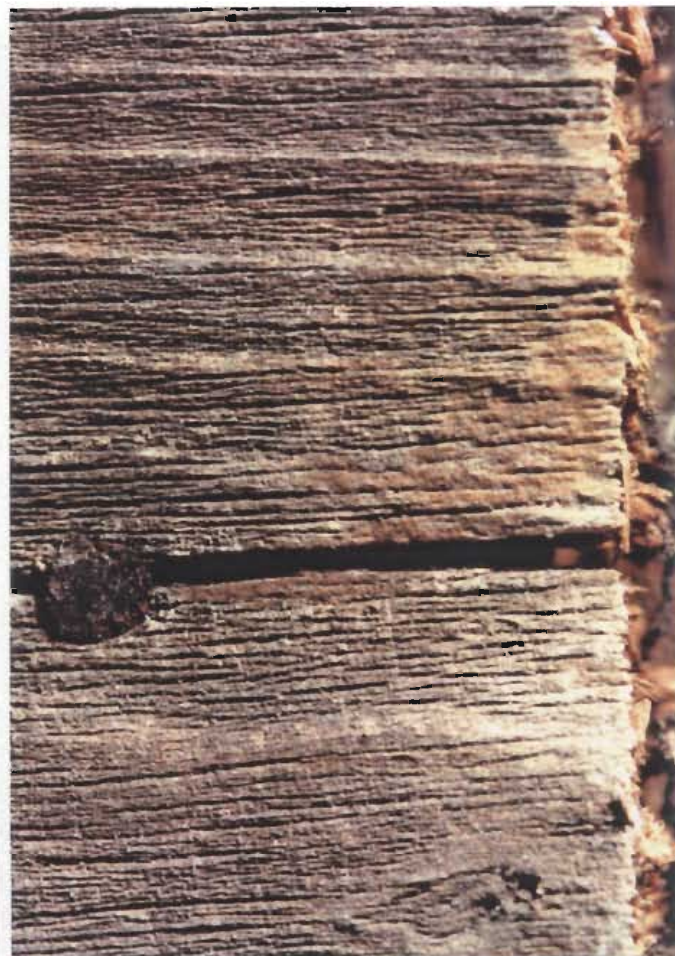
112 - 18

The older, split-board, lath (nearest the window) was made from re-used exterior window casing (photo 18).

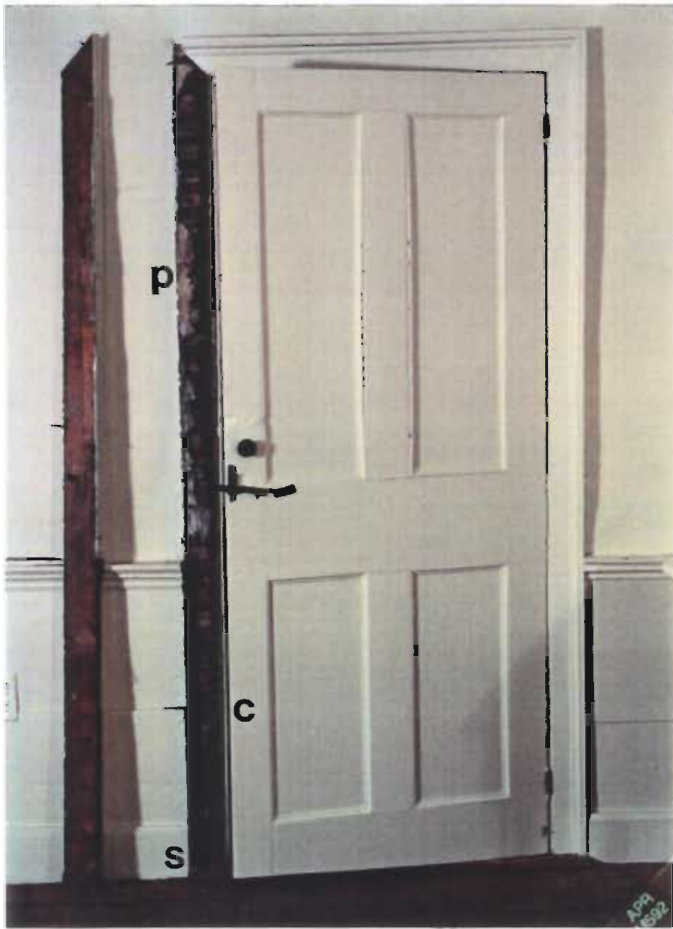
112 - 19

Removing a casing piece from the kitchen door revealed that the opening was originally occupied by a window. Beneath the casing are the ends of early riven lath attached with wrought nails, the same finishing system found on the west wall, and probably the room's first wall covering. Paint lines on fragments of early plaster under the casing (at **P**) indicate that there was a framed opening here before the present door was added. Marks on the lower third of the exposed stud (**C** in photo 22, where position is located in photo 19 is typical) show that lath originally extended across the opening from that point. This evidence describes an early window opening rather than a door.

A fragment of unpainted baseboard (**S** in photos 19 & 21) is visible at the bottom of the excavation, further evidence that the room's woodwork remained unpainted until the Federal-period remodeling.

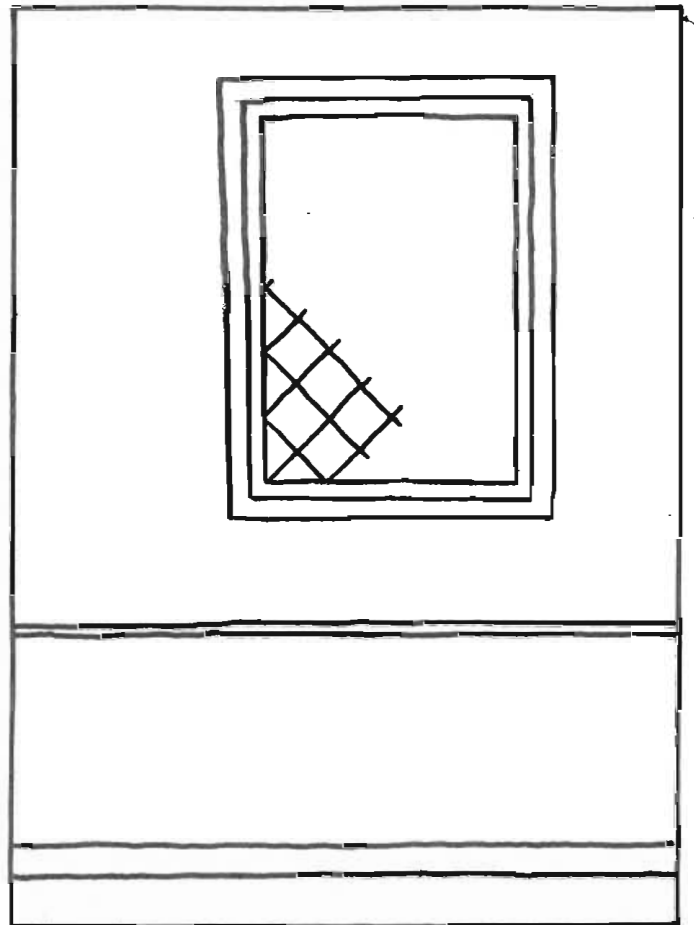
112 - 20

The door opening probably replaced the window when the lean-to **was added**. Drawing 20 illustrates the original appearance of the area in photo 19 (the pane size and configuration are conjectural). The dotted lines on the elevation drawing below trace the window's approximate dimensions.

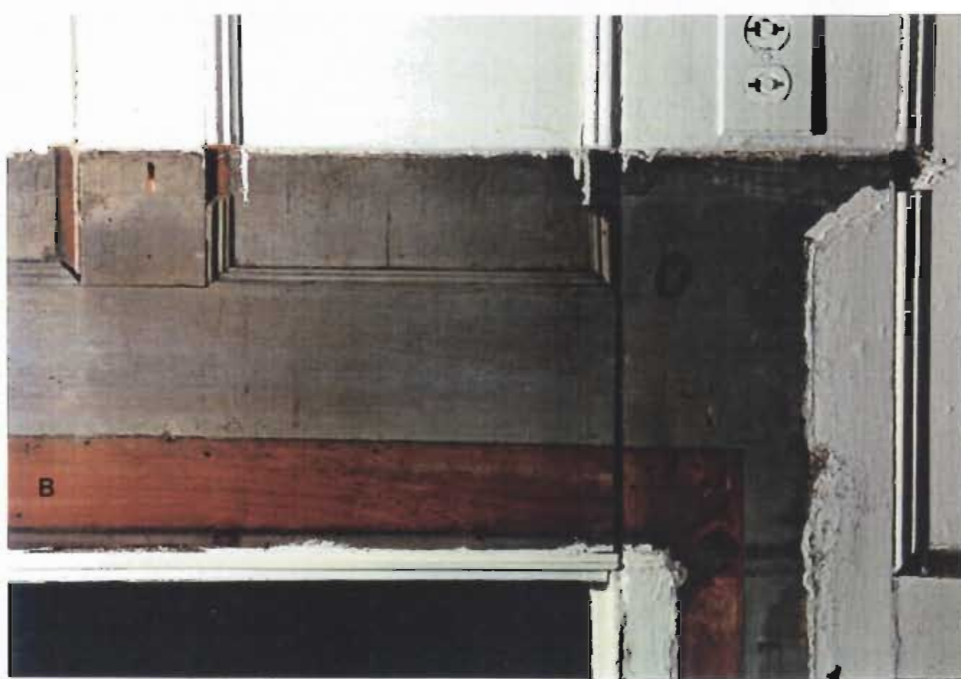
112 - 23

In detaching the room's Federal-style mantelpiece, it was found to be a later addition, and not contemporary with the c. 1800 paneled wall behind. Underneath the mantel were two layers of paint, a deep blue (the original color of the Federal-period **woodwork**), followed by a much lighter blue-green (visible in the photos). A paint line through both of these layers describes an earlier, 2 $\frac{3}{4}$ " wide, bolection moulding (located at B in photos 23 & 25), attached with wrought nails. The bolection was removed when the present mantel was added, probably before 1825.

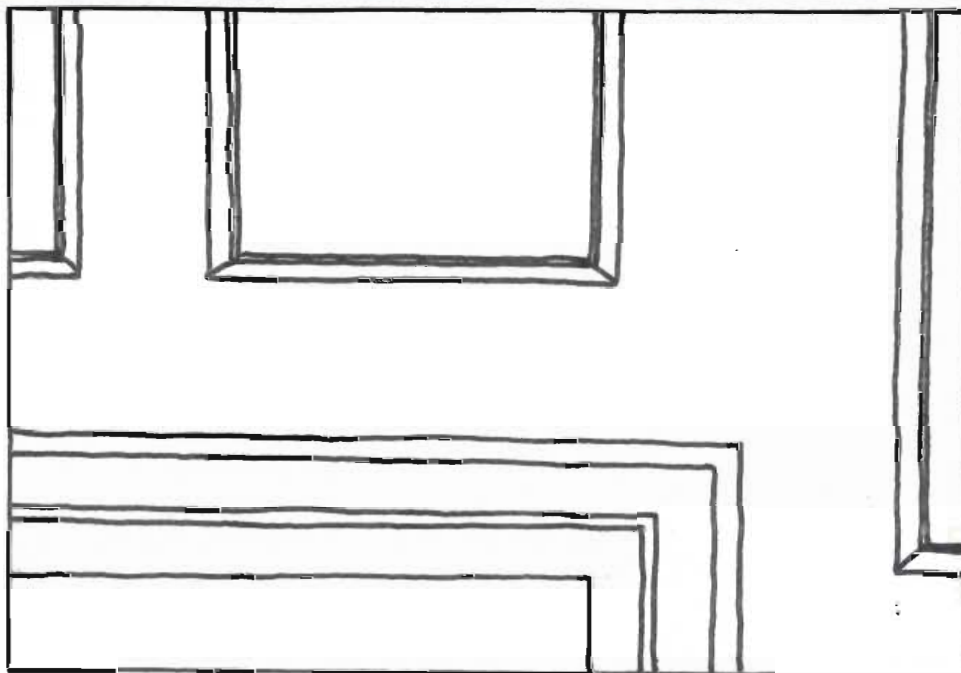
112 - 24

Drawing 24 describes the area of photo 23 as it appeared c. 1800 with the bolection moulding. The dotted line in the elevation drawing shows the location of the bolection paint lines behind the later mantel.

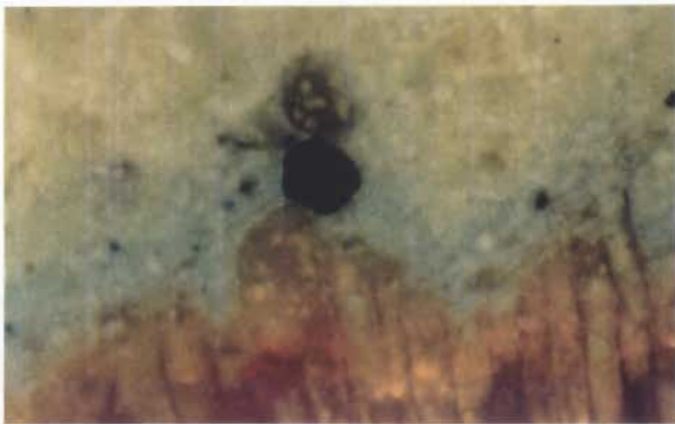
Microphotograph of paint cross-section taken from paneled wall behind mantel. The bright blue layer next to the wood (beneath a green) was not detected elsewhere in the room. The undispersed particles of blue pigment in the center of the photograph is of a shade characteristic of Prussian Blue but this was left unconfirmed.
