## ROOM 210

### Parlor Chamber

## EXCAVATION 210-A

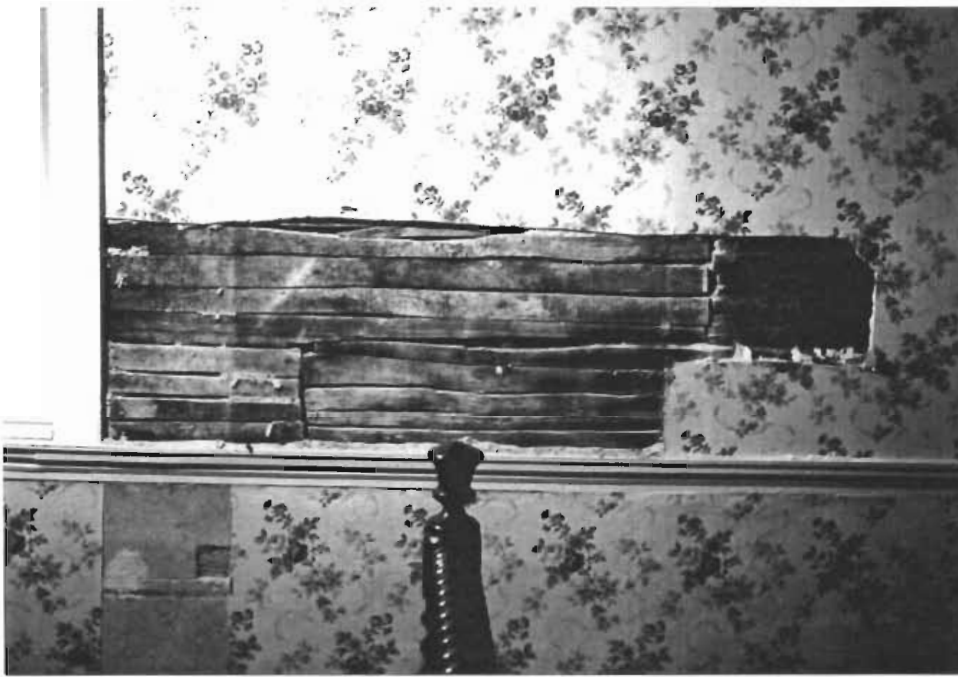
210 - 1

This excavation was intended to determine when the parlor chamber was first finished. A large area of plaster was removed from the west wall, revealing split-board lath attached with cut nails (photo 1). These materials date the plaster to the 1790s or later. Two sections of lath were then carefully removed and the studs behind checked for earlier nail holes (photo 2). None were found, indicating that the present late-eighteenth or early-nineteenth century plaster was the first plaster applied to the walls of this room.

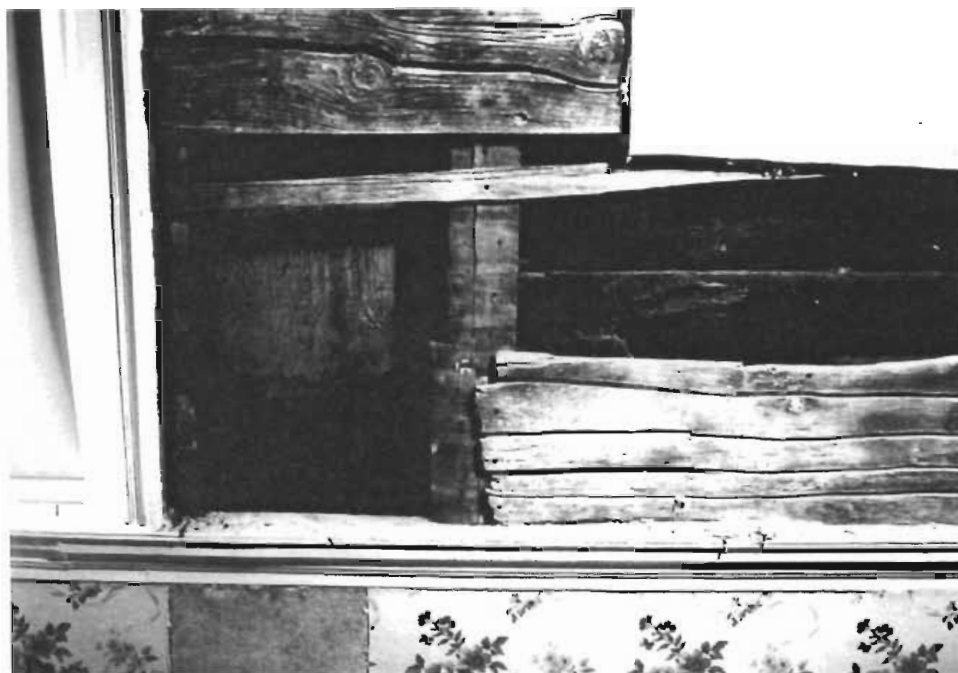
210 - 3

The cut incidentally revealed an earlier window opening. One of the studs has been obviously cut to receive a window casing, while a square cut in an adjacent weather-board received an exterior sill (photo 3). We did not look for the southerly dimension of this opening, but its northerly edge is in line with a 5' wide opening in the room below, which likely held a bank of casement windows (see room 112). Drawing 4 shows how the area in photo 3 probably looked in the early 18th century.

Most of the lath we discovered to the right of this window opening was made from weathered pieces of beaded exterior window casing, the same material discovered behind first floor plaster.

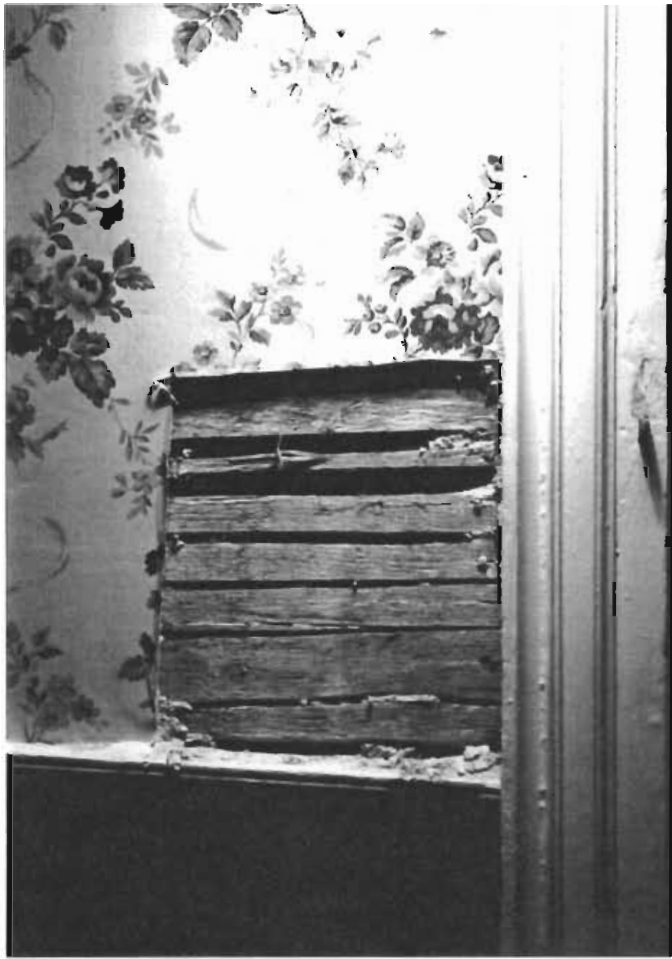
210 - 5

We cut holes into the plaster on the north and south walls merely to confirm that the split-board lath found on the west wall was general to the room. It is, although the lath in these locations is derived from regular sawn boards, rather than re-used exterior window casings.
