## SECOND FLOOR FRAMING

## THE CHIMNEY

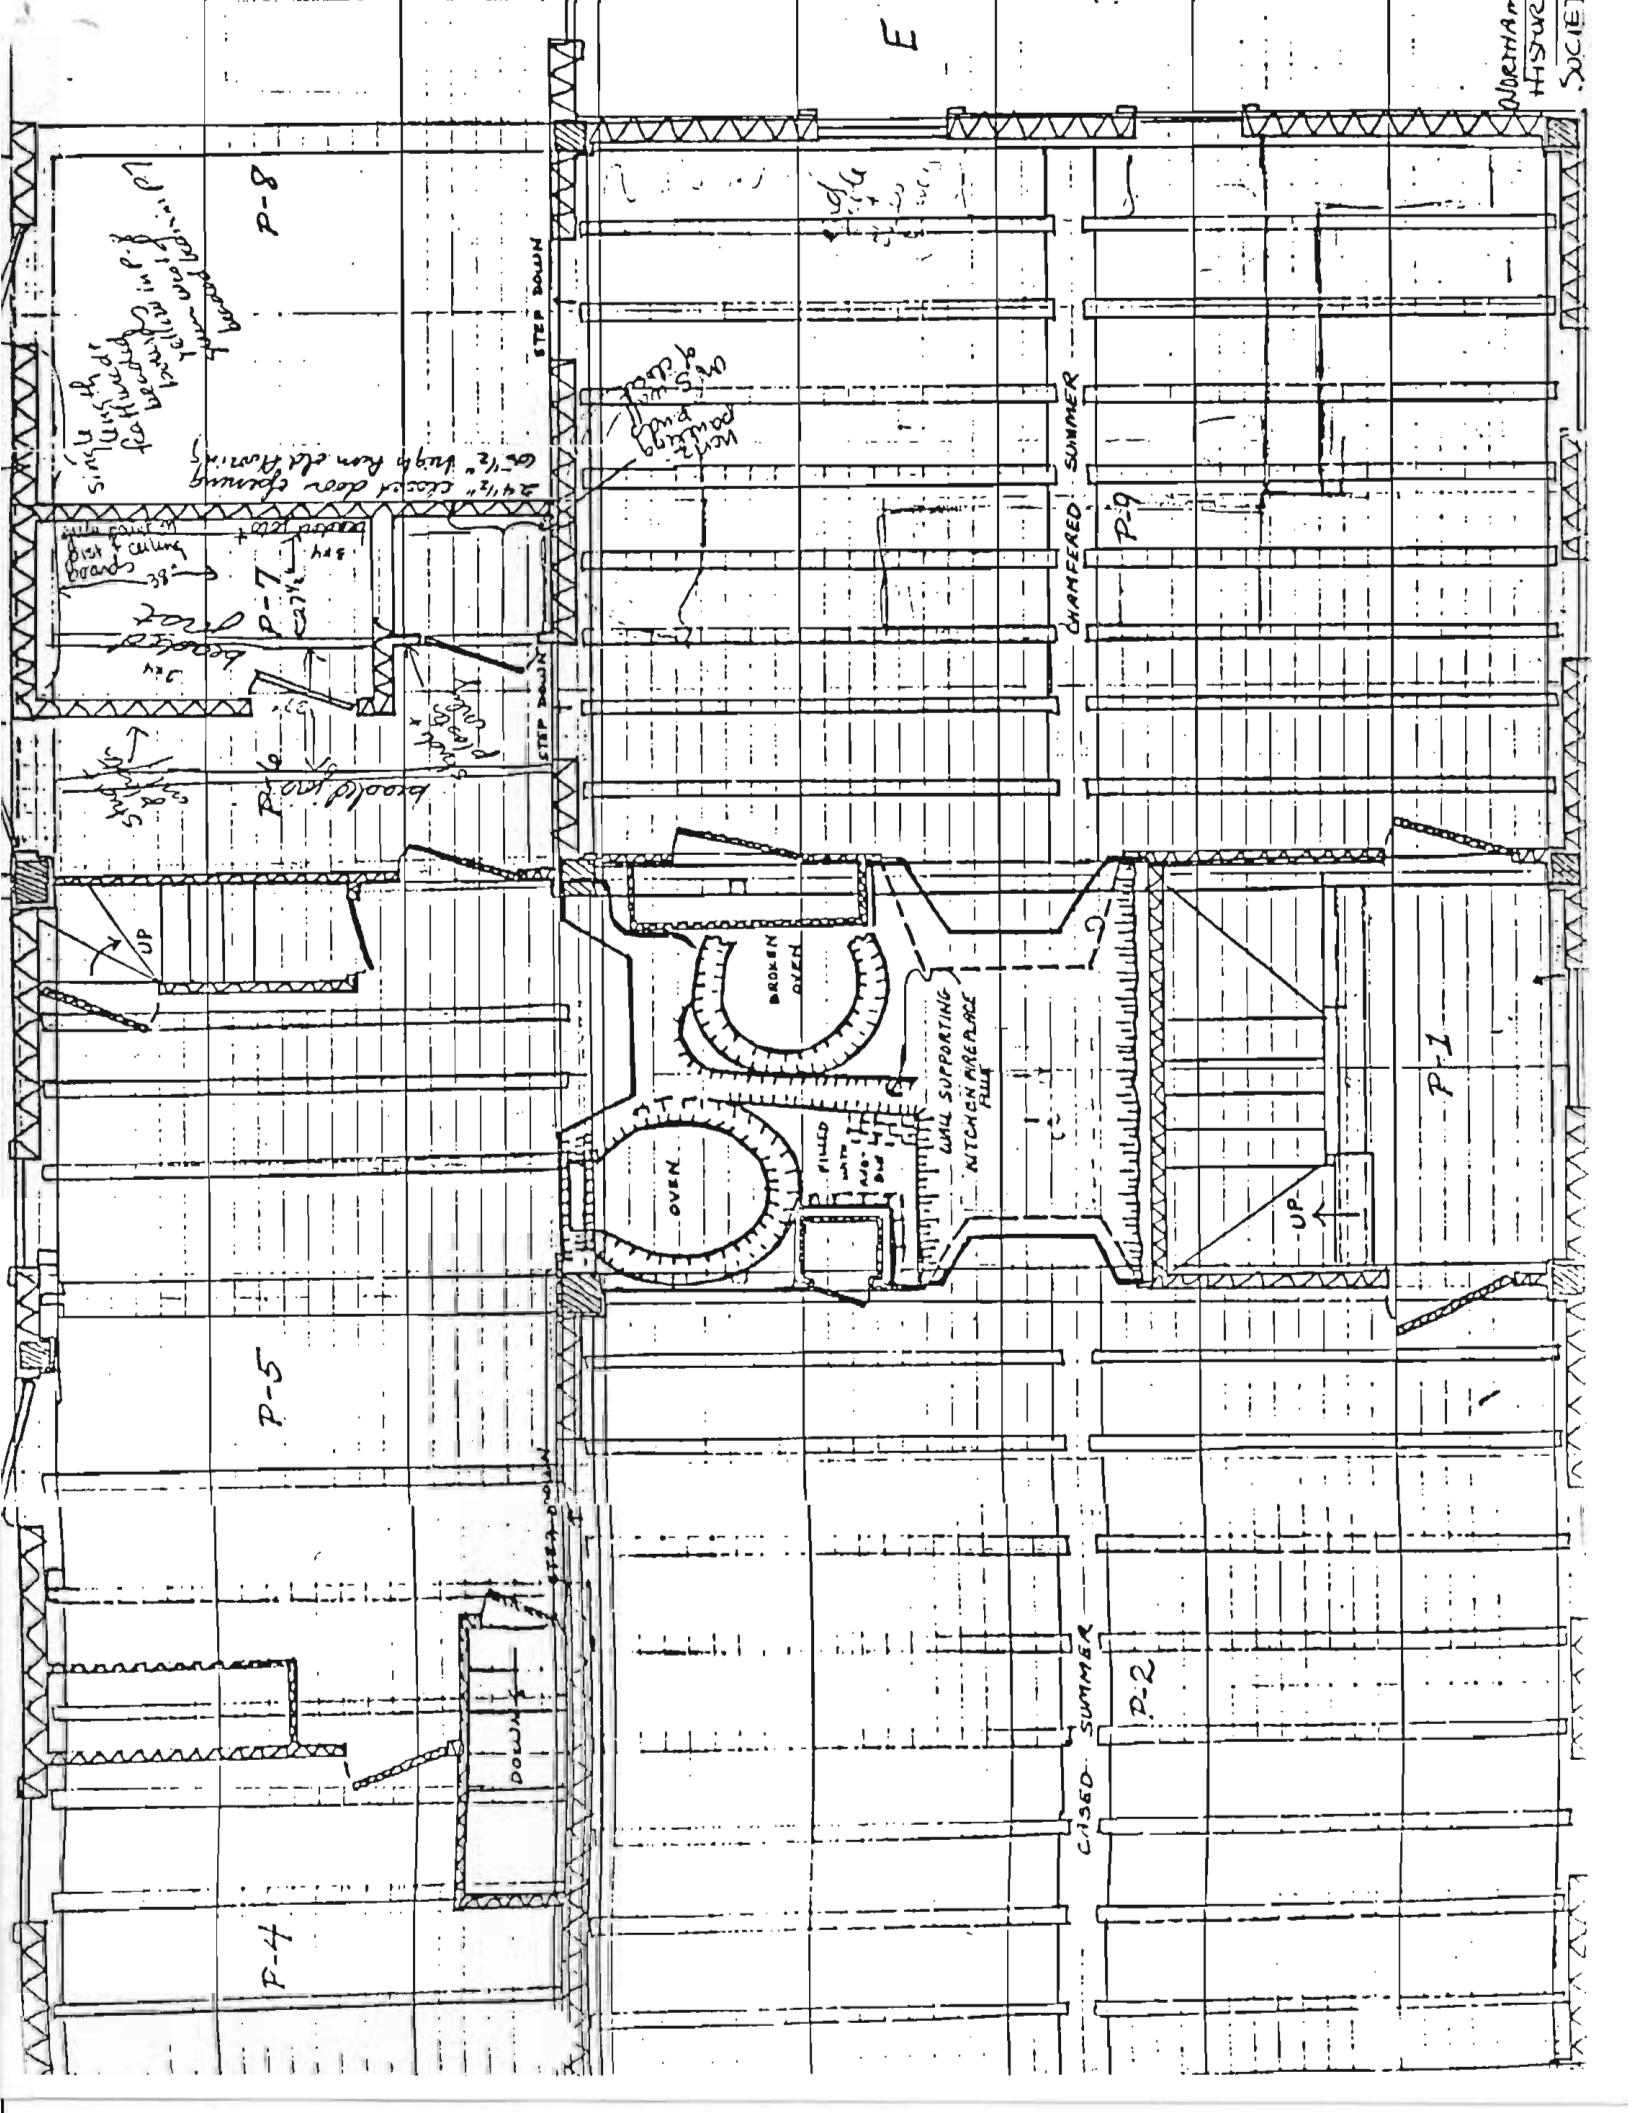
The plan at right, probably drawn by former curator Nancy Rexford c. 1981, is our only complete record of the framing between the first and second floors. The locations of the major elements have been confirmed during the present investigation, some through excavation.

The Rexford drawing was based upon an investigation conducted in 1981. The large fireplace opening and remains of an oven facing room 102 clearly identify that space as the original kitchen. The room ceased being a kitchen c. 1800, when the fireplace was reduced in size, a Federal-style mantel added, and a cupboard built in front of the oven.

The present kitchen fireplace and oven were added when the lean-to was built, in the third quarter of the 18th century.
