THE ATTIC FLOOR FRAME AND ROOF STRUCTURE

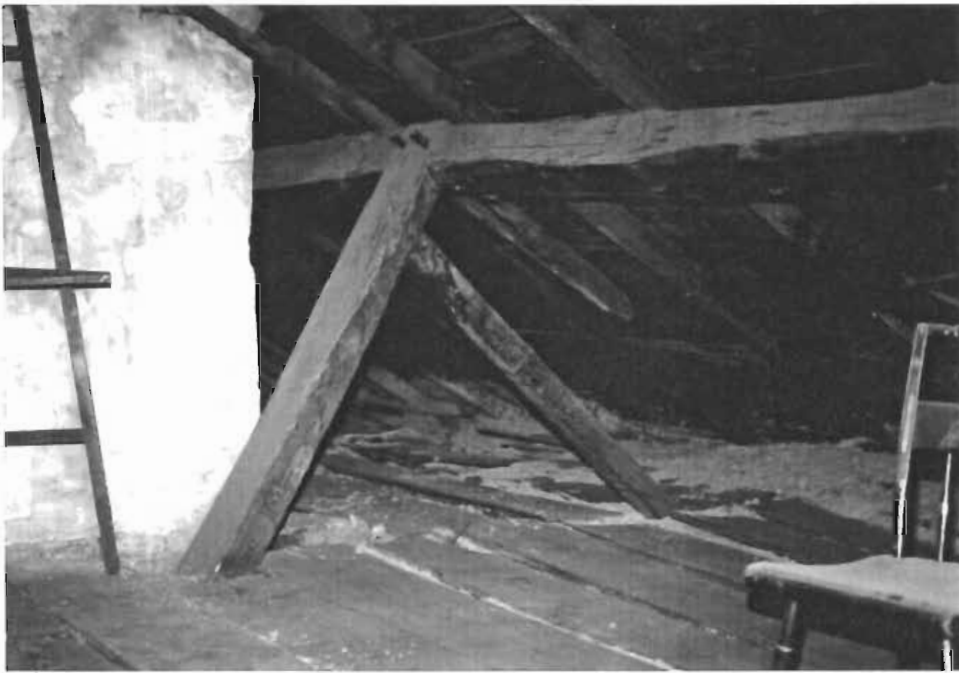
EXT - 43

The present roof dates to the major remodeling of c. 1800. The rafters are supported by a massive central purlin pegged into a series of diagonal braces (photo 43 and 44). The rafter ends are pegged into a pentagonal ridge pole (photo 45). This roof system is typical of the period around 1800.
