THE CELLAR AND FIRST FLOOR FRAME

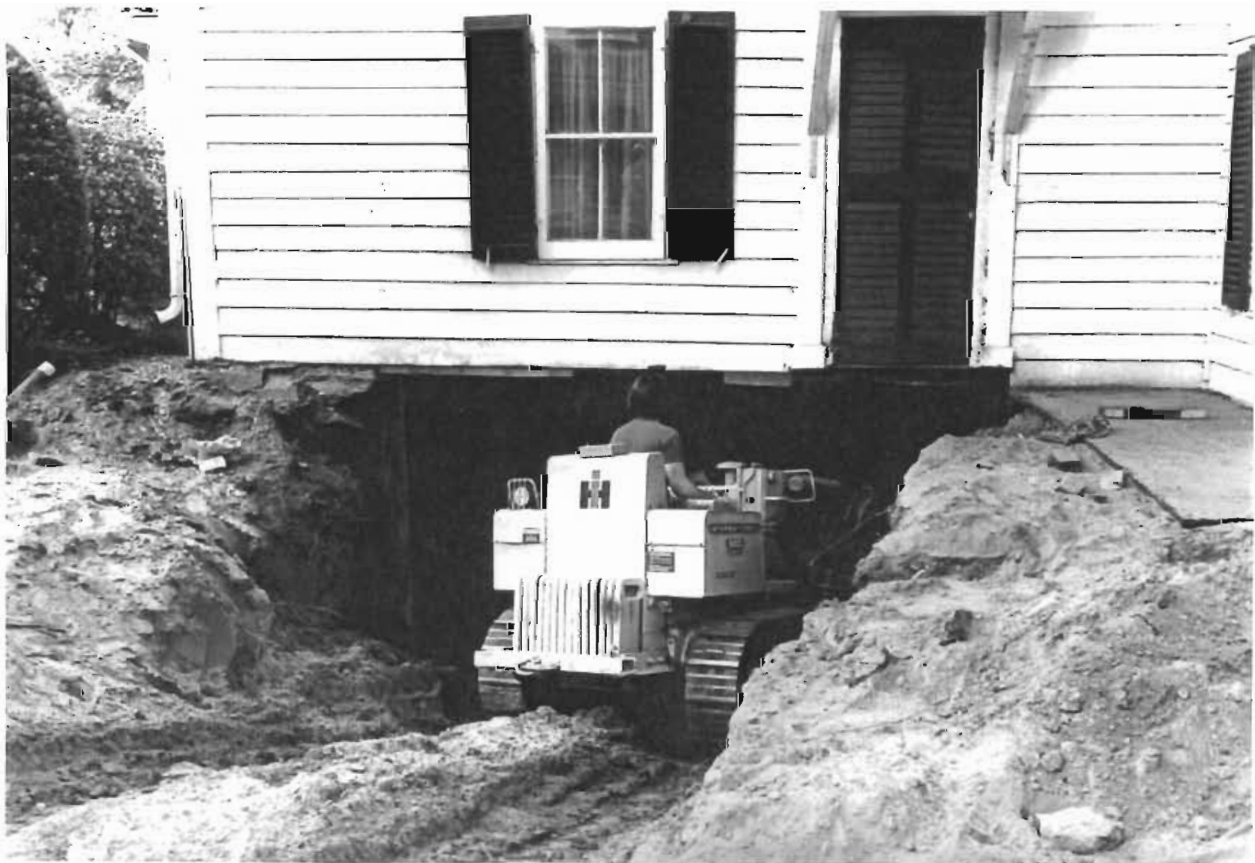
Both the cellar and first floor frame have been greatly altered by later work, and provide little physical evidence to aid our inquiry. The east half of the cellar (**the lower part of the drawing at right, probably c. 1981 by former curator Nancy Rexford**) was only excavated in 1981, and the floor framing entirely replaced. The original framing in the west half of the cellar was replaced sometime earlier.

According to Rexford's plan and her supporting notes, the evenly-spaced stringers under the easterly room lay over an unexcavated crawlspace. The stair leading from this room to the cellar under the west end of the house was composed of half logs. Unfortunately, this log staircase was lost in the course of excavation, and we can not know whether it and the west cellar are original to the house.

The ell still lies over unexcavated crawlspace. The stairwell from the ell to the westerly cellar is relatively late (c. 1800).
