ROOM 110

An Early, Reused Door

Early Paint

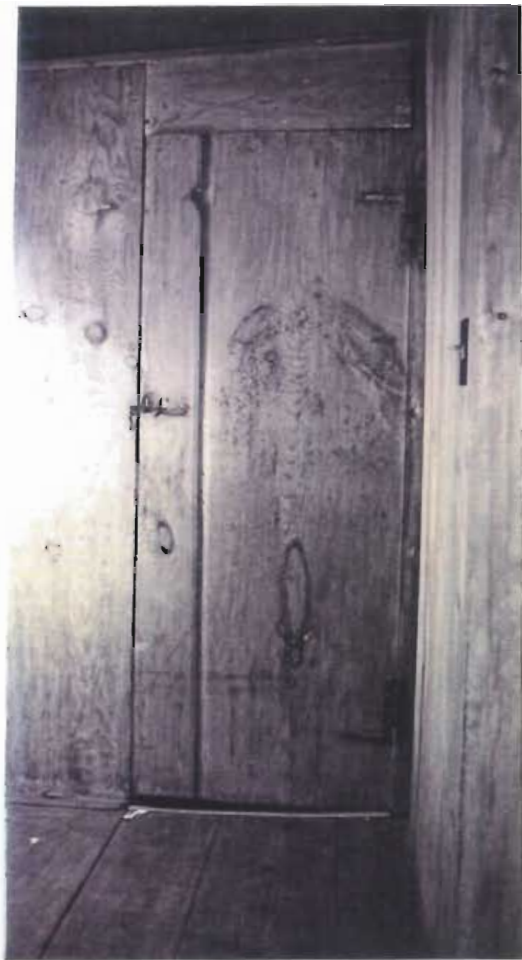
110 - 1

The door between the kitchen and buttery is earlier than the surrounding partition, and may be the earliest surviving door in the house. Its design - two lapped boards with a moulded joint fastened together by three cross-planks - was typical of doors between ancillary spaces in the later eighteenth century. Unlike the other woodwork in the partition, the door is put together with wrought nails, which also fasten the hardware - H-L hinges (photo 3) and a Suffolk latch (photo 4). The hinges were moved with the door - they are held to the door with wrought nails, but held to the partitions with later cut nails.

The inscription "-ARRS" is traceable on the thumber of the Suffolk latch, probably the name of its maker. According to Richard Everett, a collector in East Haddam, Conn., the name is likely "I. Barrs", an English latch maker active in the period 1755-1770 (Letter R. Everett to N. Rexford, Aug. 22, 1979, in HN archives).

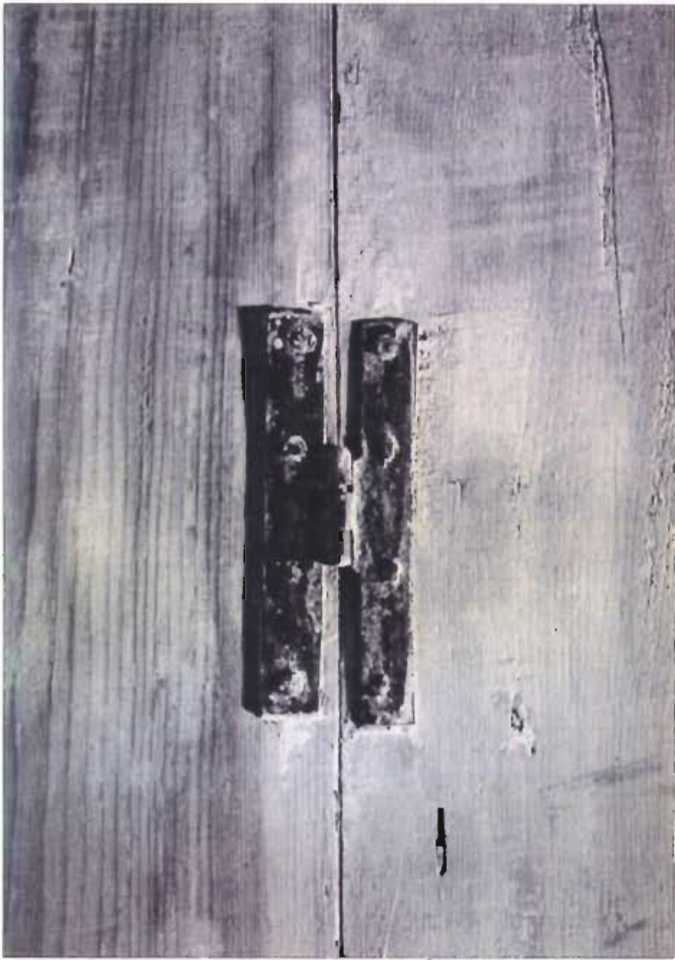
110 - 5

The cupboard doors are hung on small H-hinges (**photo 5**) fastened with cut nails. These were a bit archaic for finished rooms by the early nineteenth century, but their use survived longer in ancillary spaces.

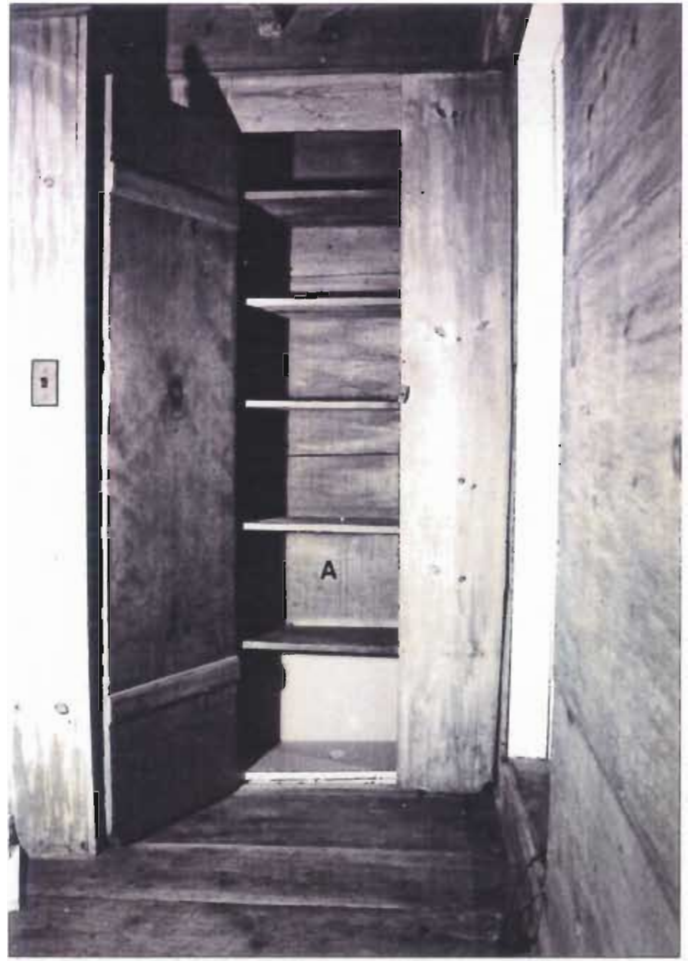
110 - 6

The horizontal boards at the back of the cupboard (**A in photo 6**), which continue unbroken from the cellar stairwell, acted as the south wall of this space before the cupboard and cellar stairs were added. They are still covered with yellow paint, the last kitchen color before the Federal-period partitioning.

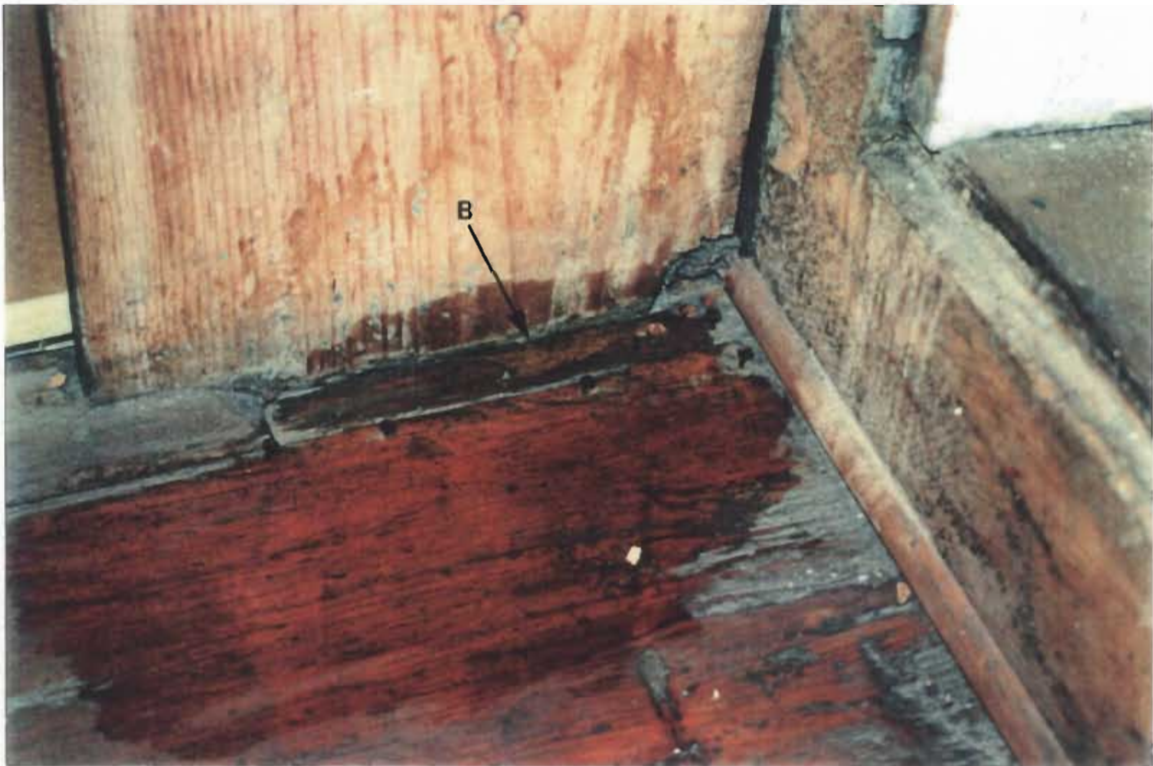
110 - 7

A small area of yellow floor paint survives in front of the cupboard (**B in photo 7**). This roughly corresponds in color to the paint fragment on the floorboards within the cellar stairwell (**photos 109-13**), suggesting that it too pre-dates the Federal changes.
