ROOM 102

The Original Kitchen/Parlor

Fireplace evidence indicates that this room was the kitchen of the original house. The walls were sheathed with molded horizontal boards, the ceiling joists were exposed, the windows were smaller - and probably of the casement type - and there were only three doors (to the hall, the cellar, and the easterly yard).

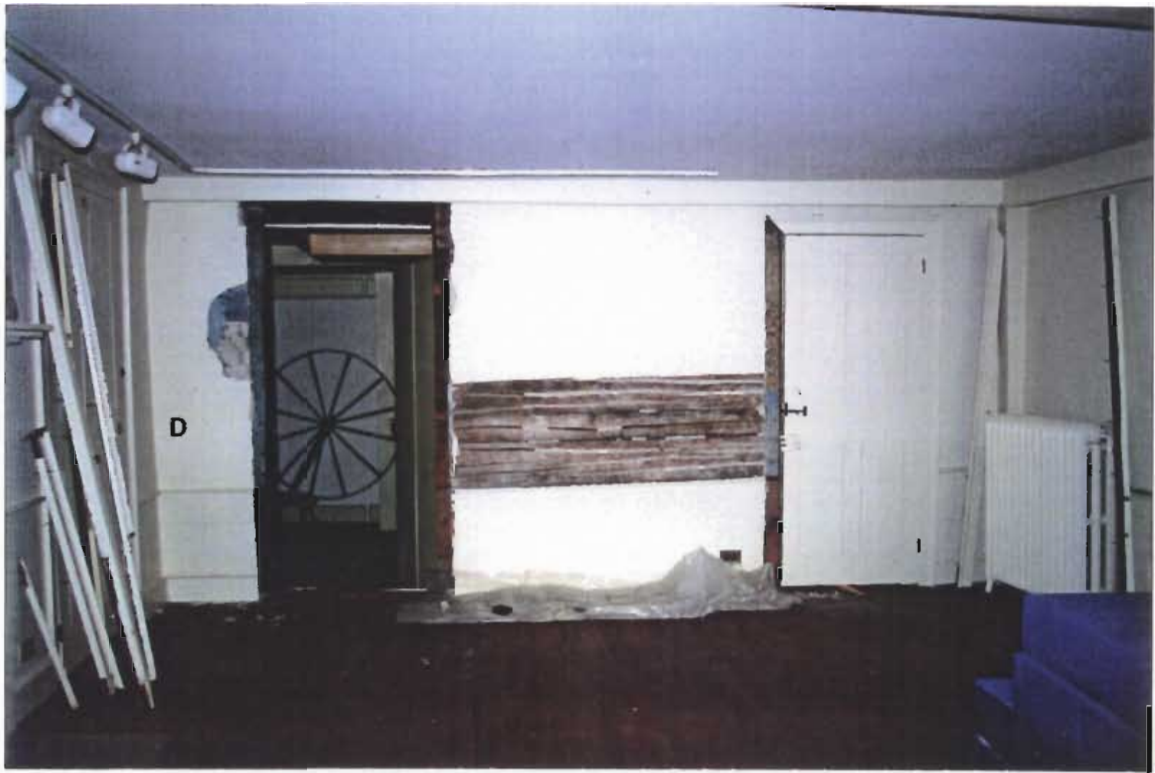
This wall was originally (c. 1725-35) sheathed with horizontal, moulded boarding, which still survives under the plaster. A narrow strip of the material was exposed by removing the casing of the left-hand door (F).

Both door openings in this wall were cut through at later dates. The left-hand opening, which probably replaced an original window, dates to either c. 1750-80, when the lean-to was added, or c. 1800, when the room was given its present plaster and Federal-style woodwork. In any case, the door which was here c. 1800 was slightly narrower than the present opening, its left jamb located at (A) in photo 2. A wider door was installed c. 1815, requiring that the left casing be moved a few inches further left. Between these two events, the wall was painted with a blue distemper, and later given a blue paper, both of which were fortuitously entombed under the moved casing (B).

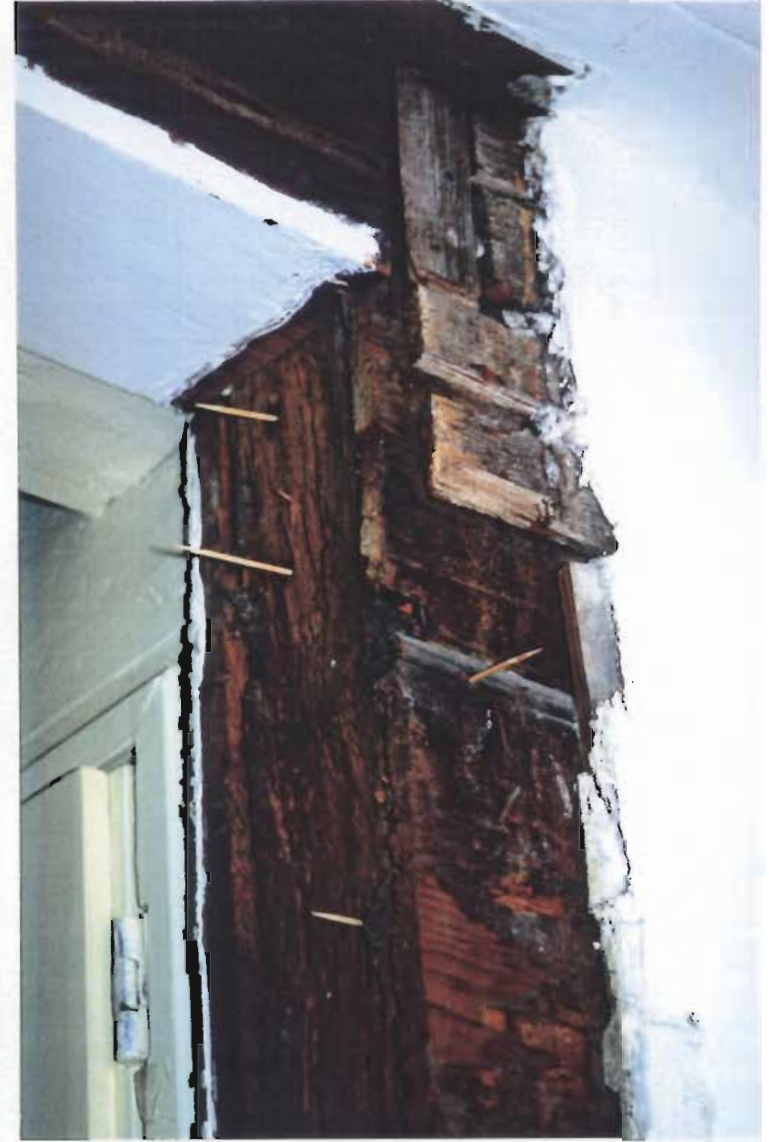
The nail evidence is corroborated by a cavity in the outer face of the westerly stud (photo 10) - mirrored by a smaller cavity in the easterly stud (arrow in photo 11) - characteristic of water damage just below a window sill.

A third piece of corroborating evidence are the two sheathing boards below the rotten areas on either side of the door frame (a & b in photos 10 and 11). These appear to have once spanned the opening, while the sheathing boards above and to either side of the door do not align.

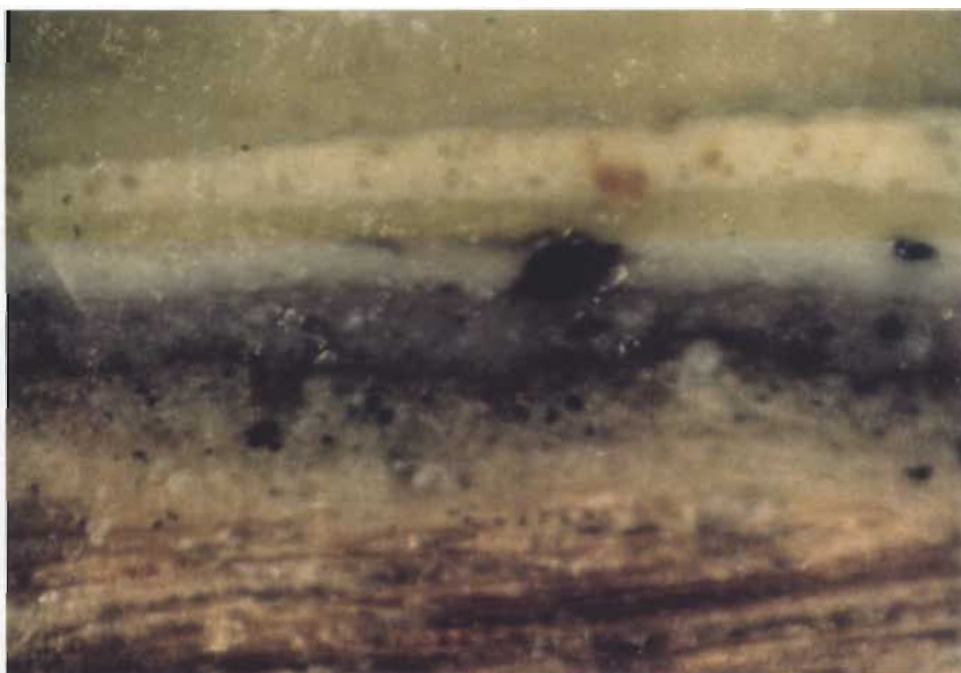
WOODWORK
PAINT LAYERS

7 Ochre (matches B17195)

4 Mauve (likely unker-based)

Microphotograph of paint cross-section taken from "A" in photo 102-17 (area of varnished casing covered by door casing). The actual colors are darker than they appear.

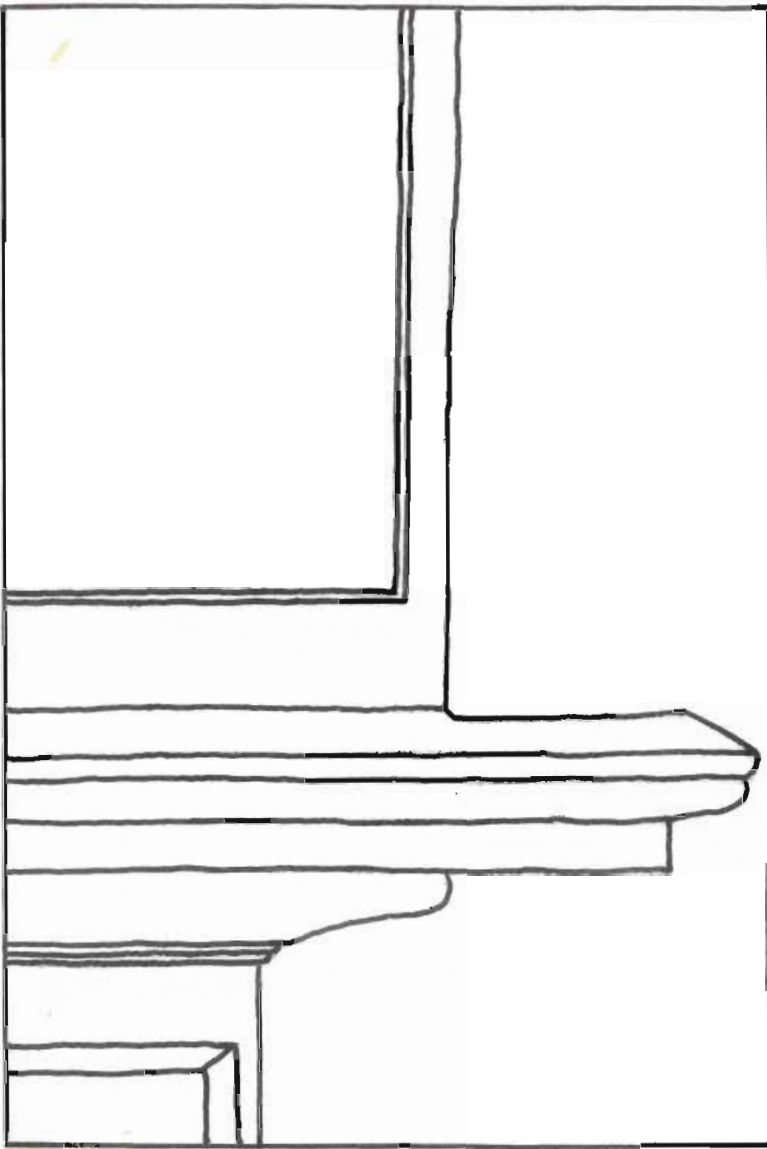
102 - 18

The drawing at right (18) illustrates one corner of the painting's border, and the dotted line in the drawing below traces its full dimension.

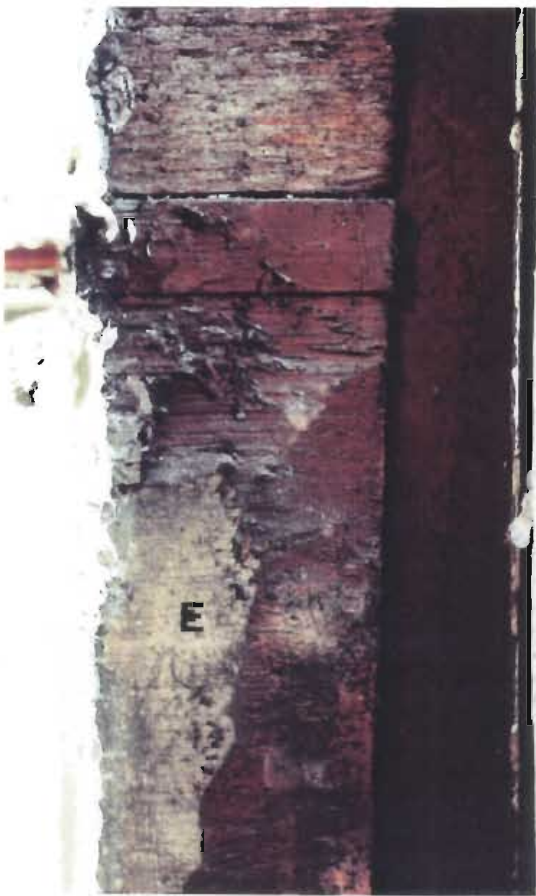
102 - 23

There is evidence that an earlier door opening stood between the present door and window on the east wall. A vertical line extends through the plaster and woodwork (**K**), from floor to ceiling, a few inches to the left of the window opening. The plaster and woodwork to the right of the line is earlier than the material to the left of it. The right-hand fabric (**G**) is identical to material elsewhere in the room which dates to c.1800, and represents the first generation of plaster finish. This plaster seems to have butted against a vertical door casing which stood to the left of **K**.

This evidence seems to describe an early door opening, which was blocked up and replaced by the present, adjacent door sometime in the first quarter of the nineteenth century. The alteration occurred after the room was plastered and the exterior weatherboarded, but still prior to about 1825 (the design of the exterior surround is Federal). The plan may have been to better center the door in the new gable end. We have conjectured **line J** as the door's left-hand dimension.

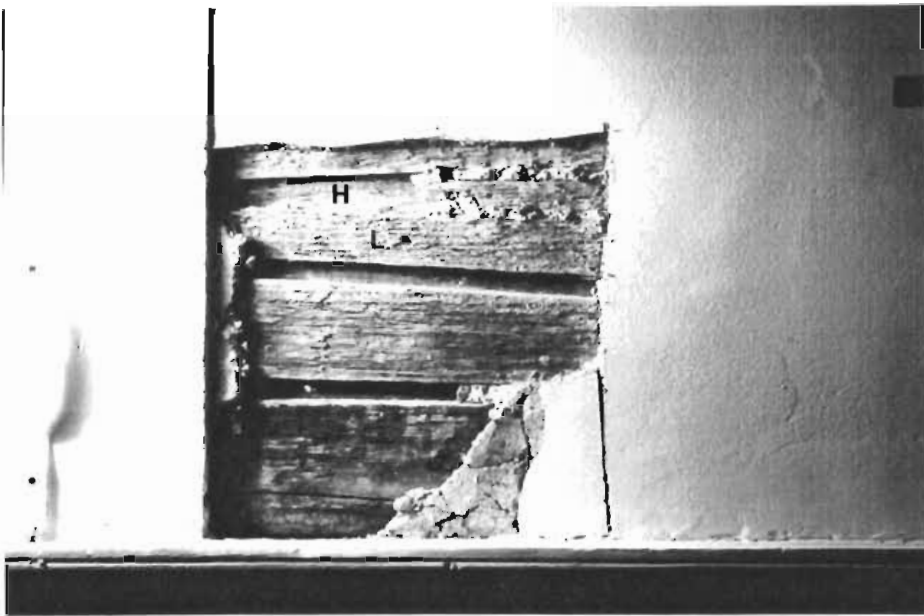
102 - 25

These excavations on the east were mainly to confirm that the horizontal sheathing found around the kitchen door was general to the room. As expected, we found the same sheathing (**H**) in both locations, under obviously Federal-period lath (**L**).

The south wall excavation also provided evidence of original but shorter window openings on the facade, in the same locations as the later (present) sash. The sheathing is cut for what were likely the bottom corners of the original openings, about six inches up the present surrounds (**W**). There are also early nail holes, marked by toothpicks in the photograph, which likely related to interior window surrounds.

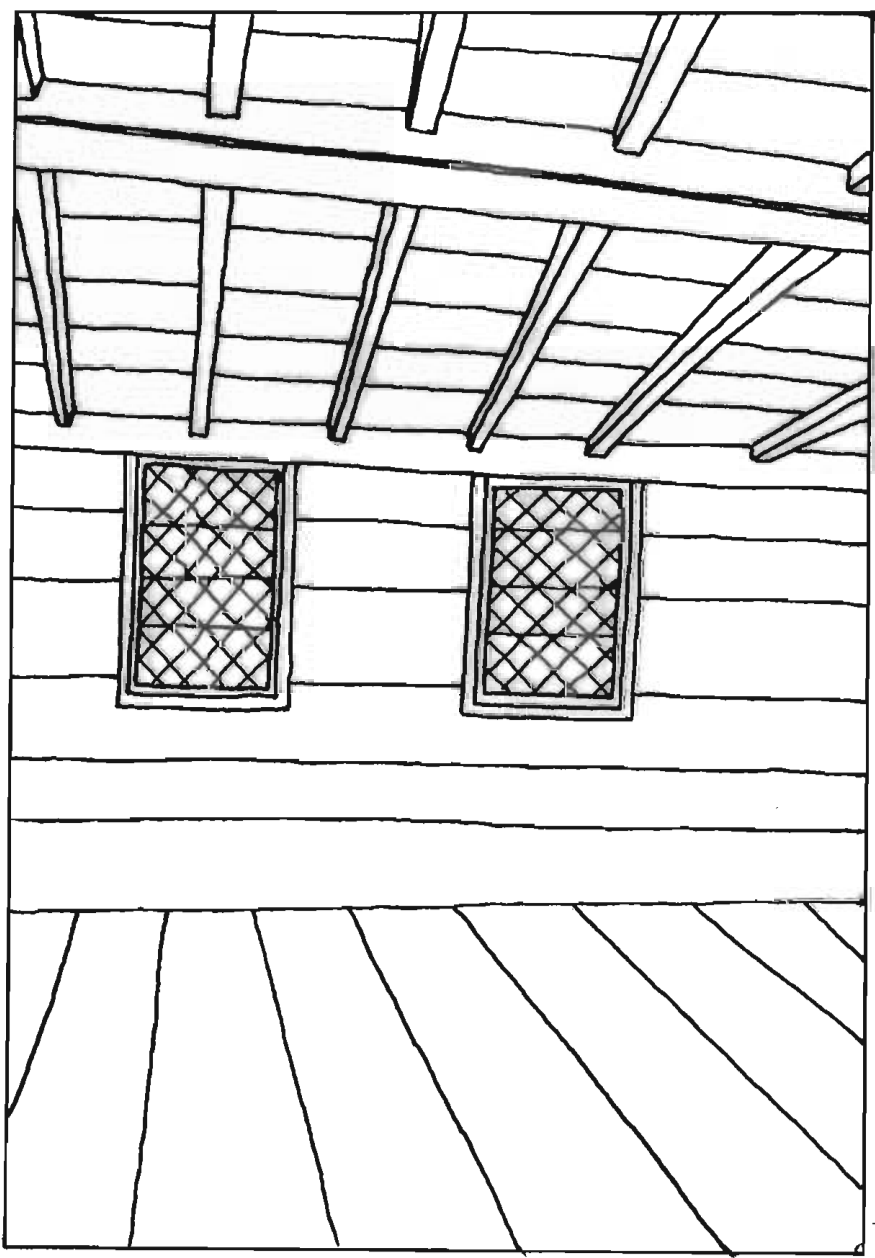
102 - 31

The drawing (31) is a sketch of how the section of room photographed in 1981 (photo 28) might have appeared in the early 18th century, based upon the available evidence.
