## ROOM 112

### A Parlor or Chamber

## EXCAVATION 112-A

### Early 18th Century Wall Plaster and Finish

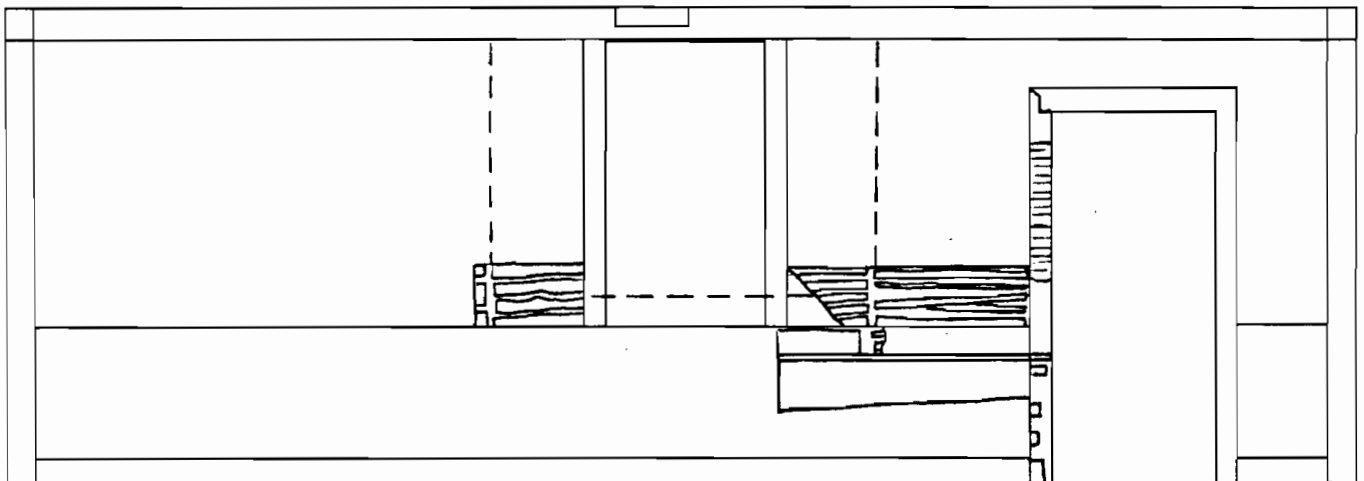
This excavation revealed that large areas of the west wall retain an archaic plaster (P), perhaps as early in date as the house itself (before 1735). Our initial cut into the plaster (photo 4) uncovered riven lath, the standard lath type in New England until the last quarter of the 18th century. We continued the excavation to the left (photo 9), locating wrought nails at the fastening point between lath and studs (R in photo 8). A piece of the Federal-period wainscot was also removed to reveal the surface of the early plaster (photos 9 & 10). Early plaster is presumably entombed behind the wainscot for the whole length of this wall.

A bank of casement windows likely occupied the center of the west wall from the early 18th century until the Federal-period remodeling (the dotted line on the elevation drawing). The present sash window is flanked on both sides by split-board lath fastened with cut nails, (**D** in photos 7 & 9). This describes a 5' wide window opening reduced and filled in during the Federal-period remodeling. We did not fully excavate the opening, but infill of the same period was found on the exterior. A similarly sized opening was located in the chamber directly above. (See excavations EXT-W and 210 W for a fuller discussion of the original fenestration.)

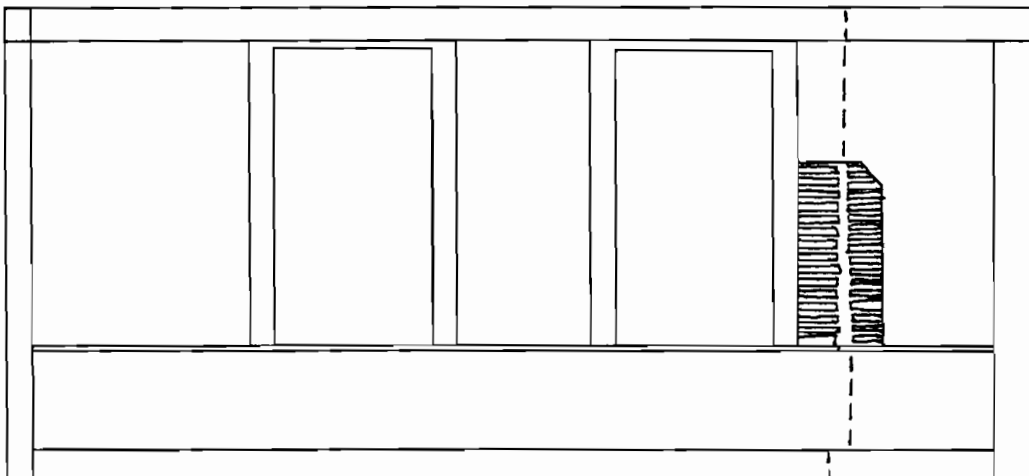
There is physical evidence that a triangular cupboard occupied the room's southwest corner for some time after the Federal-period remodeling, i.e.:

- Fragments of wainscot, chair rail and baseboards have been pieced into this corner on both sides of the post casing (inside of the lines marked W in photo 15). The baseboard on the west wall (**B**) is the exception - this seems to have been removed and replaced when the present floor was laid in the 20th century. Paint analysis confirms that the woodwork closest to the corner is later infill. In other words, the wainscoting did not originally extend into this corner.

- The break in the woodwork on the south wall corresponds with a plaster line (**T**) extending to the girt casing. Our excavation along this plaster line (**photo 17**) revealed two distinct periods of split-board lath, both held (predominantly) by cut nails. The manner in which the two plasters overlapped at the joint indicated that the lath closest to the corner was later infilled, like the wainscot below.

- There are distinct paint lines on the beam casings (**P**) directly above the joints in the woodwork. These indicate that the casings in the corner skipped a number of painting episodes early in the room's history.

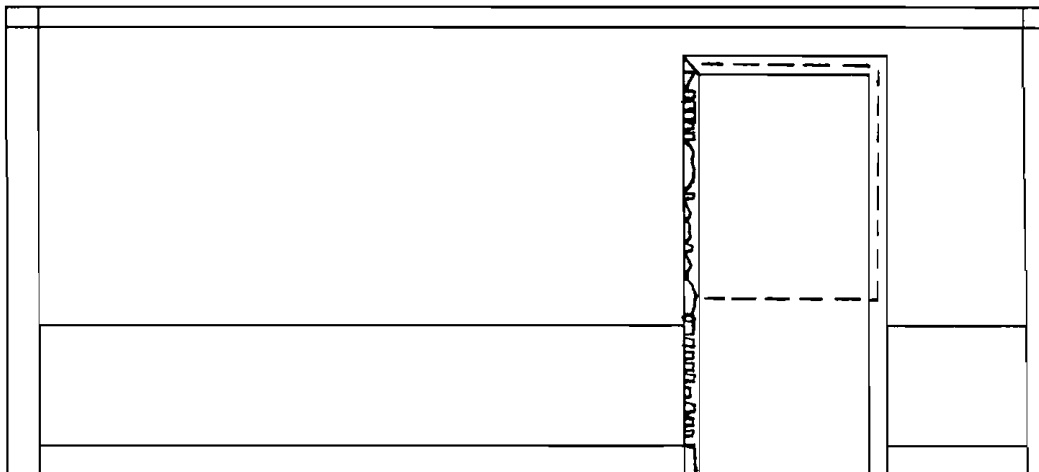
Removing a casing piece from the kitchen door revealed that the opening was originally occupied by a window. Beneath the casing are the ends of early riven lath attached with wrought nails, the same finishing system found on the west wall, and probably the room's first wall covering. Paint lines on fragments of early plaster under the casing (at **P**) indicate that there was a framed opening here before the present door was added. Marks on the lower third of the exposed stud (**C** in photo 22, where position is located in photo 19 is typical) show that lath originally extended across the opening from that point. This evidence describes an early window opening rather than a door.

The door opening probably replaced the window when the lean-to **was added**. Drawing 20 illustrates the original appearance of the area in photo 19 (the pane size and configuration are conjectural). The dotted lines on the elevation drawing below trace the window's approximate dimensions.

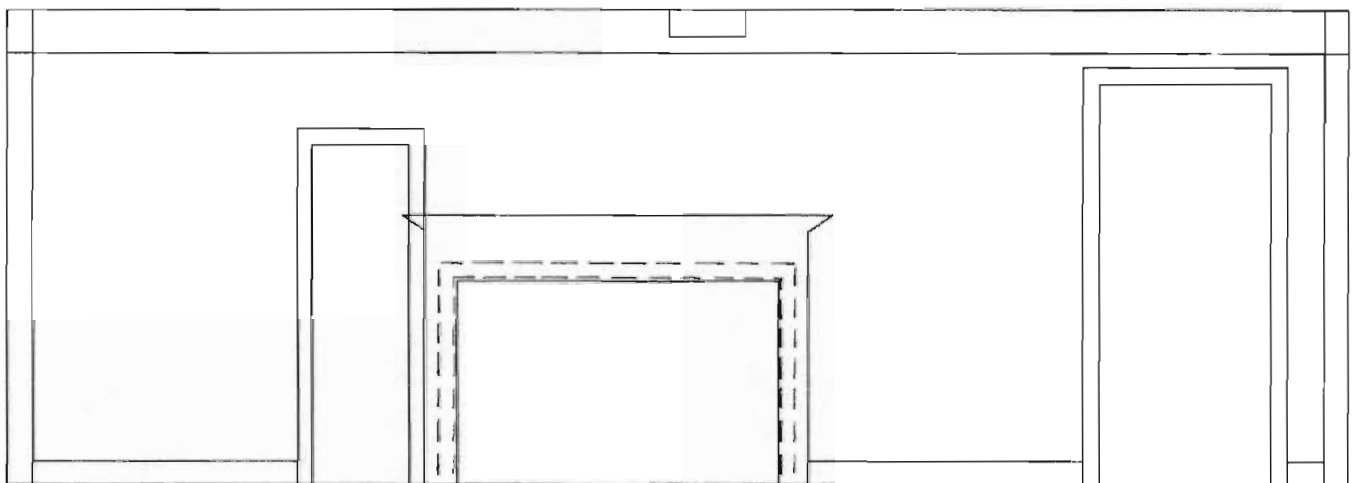
In detaching the room's Federal-style mantelpiece, it was found to be a later addition, and not contemporary with the c. 1800 paneled wall behind. Underneath the mantel were two layers of paint, a deep blue (the original color of the Federal-period **woodwork**), followed by a much lighter blue-green (visible in the photos). A paint line through both of these layers describes an earlier, 2 $\frac{3}{4}$ " wide, bolection moulding (located at B in photos 23 & 25), attached with wrought nails. The bolection was removed when the present mantel was added, probably before 1825.

Drawing 24 describes the area of photo 23 as it appeared c. 1800 with the bolection moulding. The dotted line in the elevation drawing shows the location of the bolection paint lines behind the later mantel.
