## ROOM 210

### Parlor Chamber

## EXCAVATION 210-A

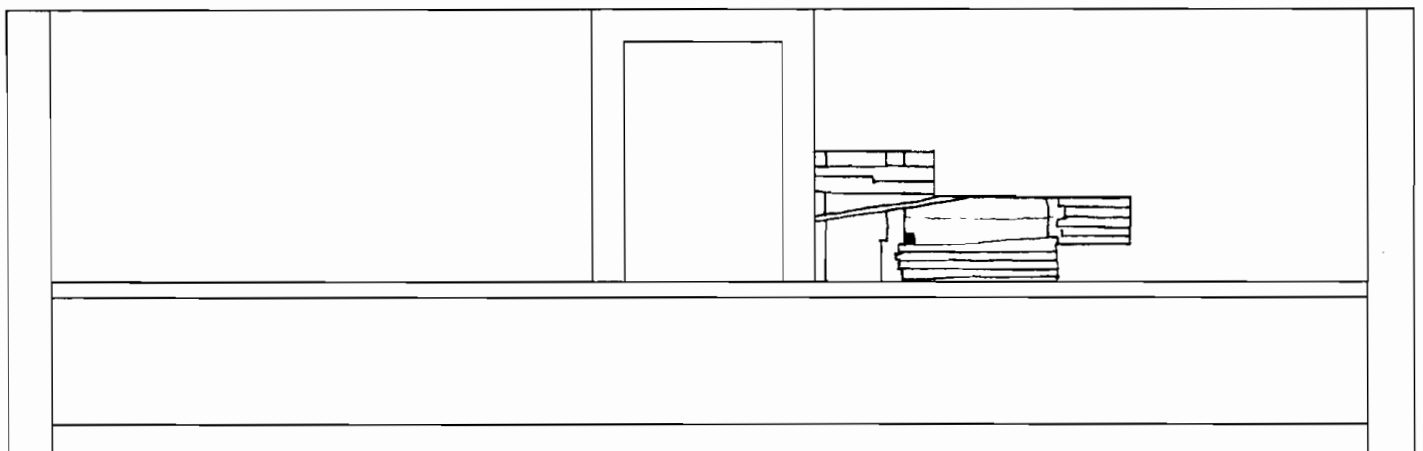
This excavation was intended to determine when the parlor chamber was first finished. A large area of plaster was removed from the west wall, revealing split-board lath attached with cut nails (photo 1). These materials date the plaster to the 1790s or later. Two sections of lath were then carefully removed and the studs behind checked for earlier nail holes (photo 2). None were found, indicating that the present late-eighteenth or early-nineteenth century plaster was the first plaster applied to the walls of this room.

The cut incidentally revealed an earlier window opening. One of the studs has been obviously cut to receive a window casing, while a square cut in an adjacent weather-board received an exterior sill (photo 3). We did not look for the southerly dimension of this opening, but its northerly edge is in line with a 5' wide opening in the room below, which likely held a bank of casement windows (see room 112). Drawing 4 shows how the area in photo 3 probably looked in the early 18th century.

Most of the lath we discovered to the right of this window opening was made from weathered pieces of beaded exterior window casing, the same material discovered behind first floor plaster.
