EXCAVATION 210-S (ORIGINAL NORTH WALL)

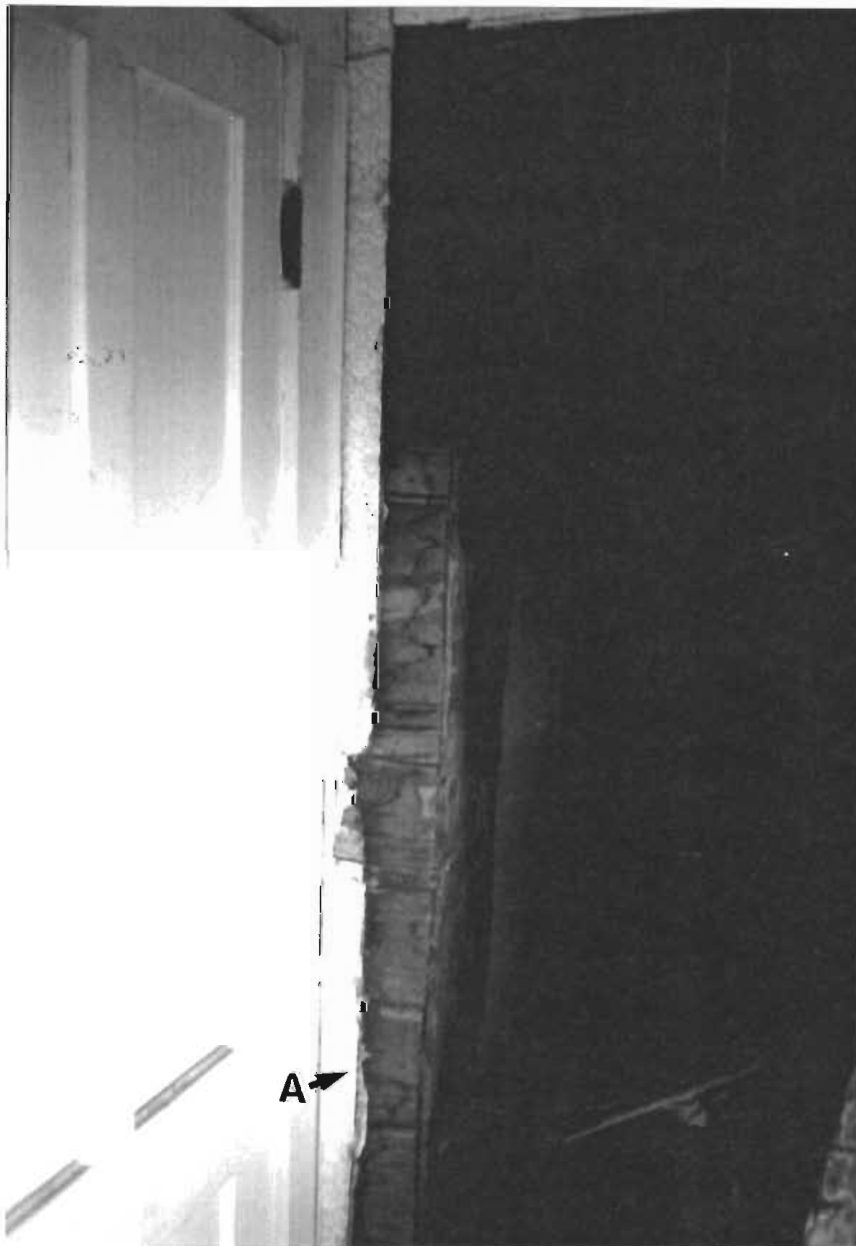
Removing the plaster and lath against the south wall of this room exposed the rear wall of the original house (photos 40 & 41), sheathed with flush boards, beveled on top and bottom, and virtually identical to those on the facade excepting the absence of horizontal score marks. The boards are attached with rose-headed wrought nails and show no evidence of painting.

Identical boards were discovered farther down this wall, beneath the casing of the attic door, during work in 1982 (A in photo 39, undated).
